Repairs during the Construction Phase
Field Studies

Report No.68
1997

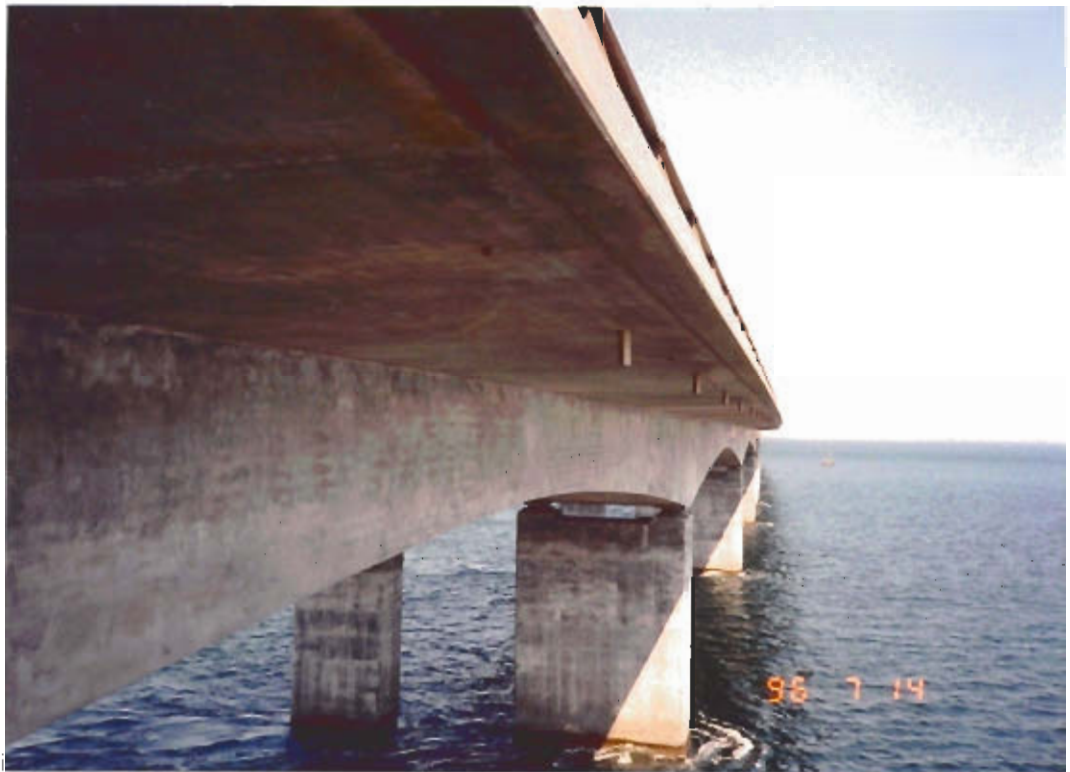
Repair method	Structure / year of completion	Testing and analyses
Repairs with concrete cast in forms	Tunnel 1996	Visual inspection of 2 repairs 4 cores Macroanalyses and microanalyses Adhesion tests
	Bridge 1 1991	Visual inspection of 1 repair 2 cores Macroanalyses and microanalyses Adhesion tests
Repair with shotcrete	Tunnel 1996	Visual inspection of 2 repairs 4 cores Macroanalyses and microanalyses Adhesion tests
	Bridge 3 1981	Visual inspection of 1 repair 2 cores Macroanalyses
	Bridge 4 approx. 1978	Visual inspection of 2 repairs 4 cores Macroanalyses and microanalyses Adhesion tests
Repair with mortar	Bridge 2 1996	Visual inspections of 2 repairs 4 cores Macroanalyses and microanalyses Adhesion tests
	Bridge 1 1991	Visual inspection of 1 repair 1 core Macroanalyses Adhesion tests
	Tunnel 1996	Visual inspection of 2 repairs 4 cores Macroanalyses and microanalyses Adhesion tests

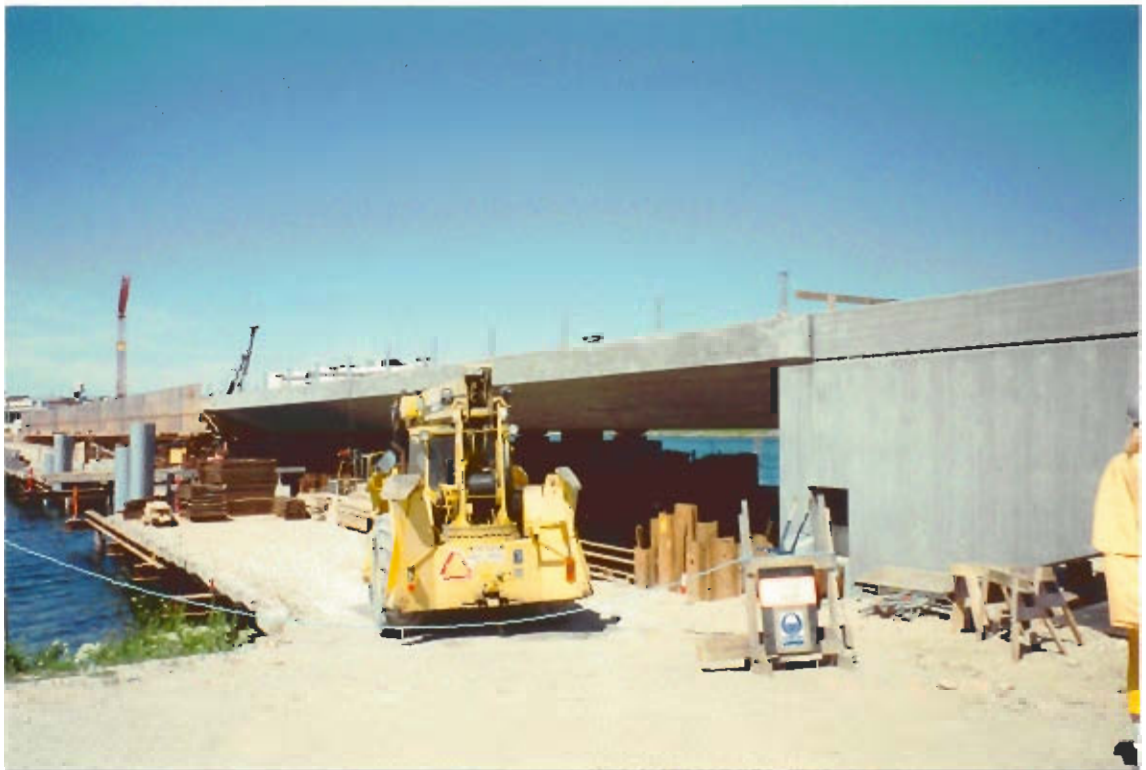
Bridge 1 was built in 1991. The two defects which were inspected were located on the side of the girder. The defects were described as bad compaction or mechanical defects. One of the defects was repaired with concrete and the other was repaired with mortar.

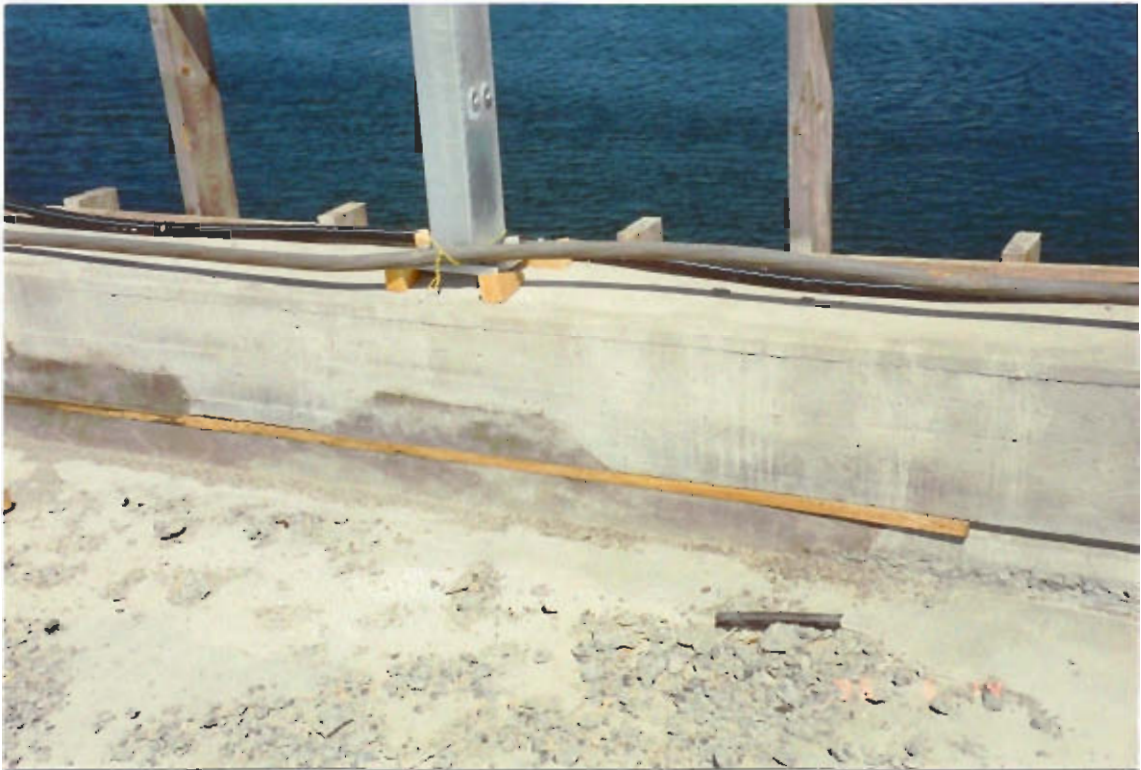
Figure 3: Repairs at the inner corner of the edge beam on bridge 2. The defect was caused by settlement of the concrete at very early age.

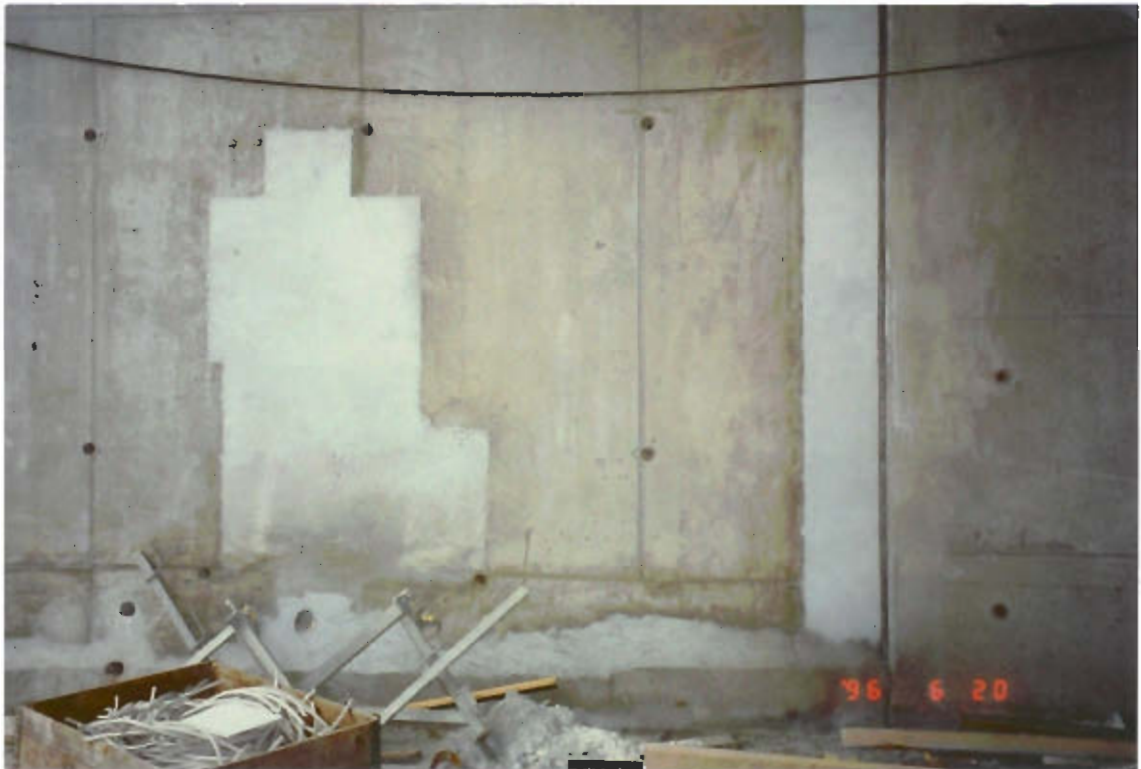
Figure 4: The tunnel was built in 1996. The six repairs which were inspected were located on the inner side of the tunnel walls from 0-2 m above bottom slab level. The defects were holes and porous areas due to bad compaction or due to ice and snow in the bottom part of the form. The holes and porous areas were repaired with repair concrete (similar to the construction concrete), mortar or shotcrete respectively.

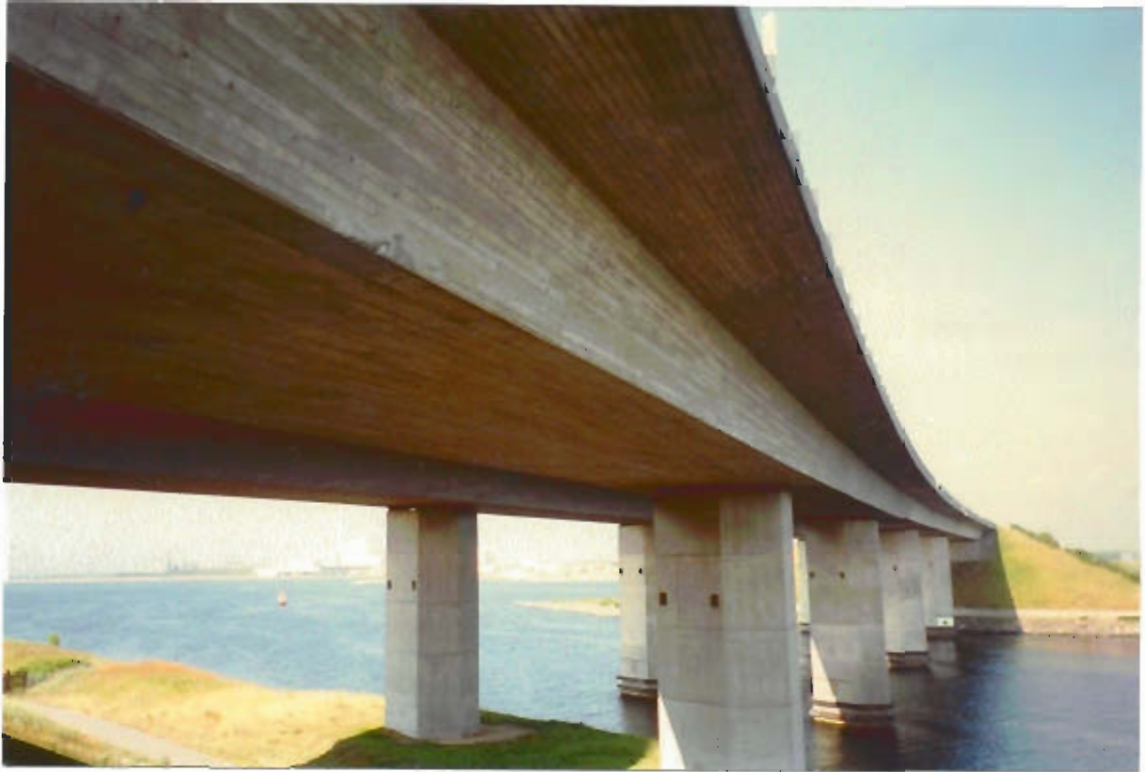
Figure 5: Bridge 3 was built in 1981. The defects which were inspected were holes from bad compaction in the bottom part of the slab due to lack of space between the prestressing ducts. The defects were repaired with shotcrete.

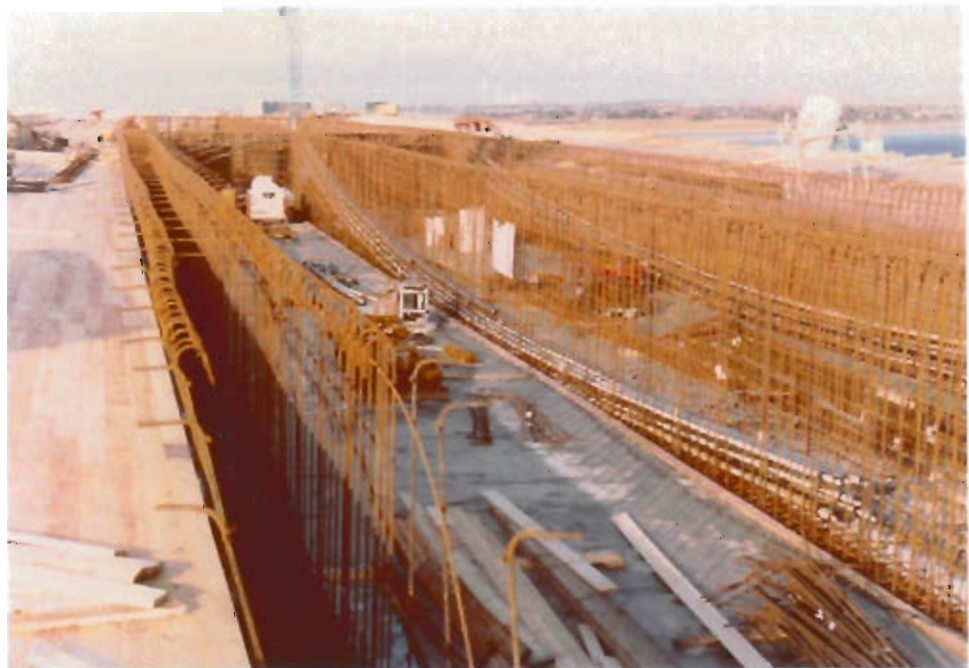
Figure 6: Bridge 3 during the construction phase. Reinforcement and prestressing ducts arranged before casting at the box girder.

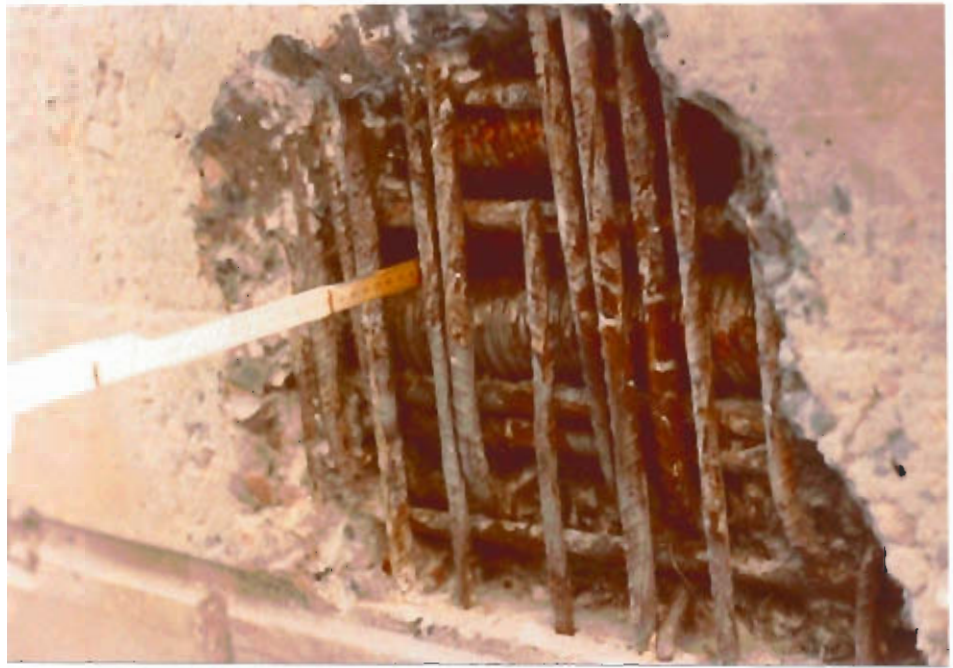
Figure 7: Underside of bridge 3 box girders after form stripping before repair.

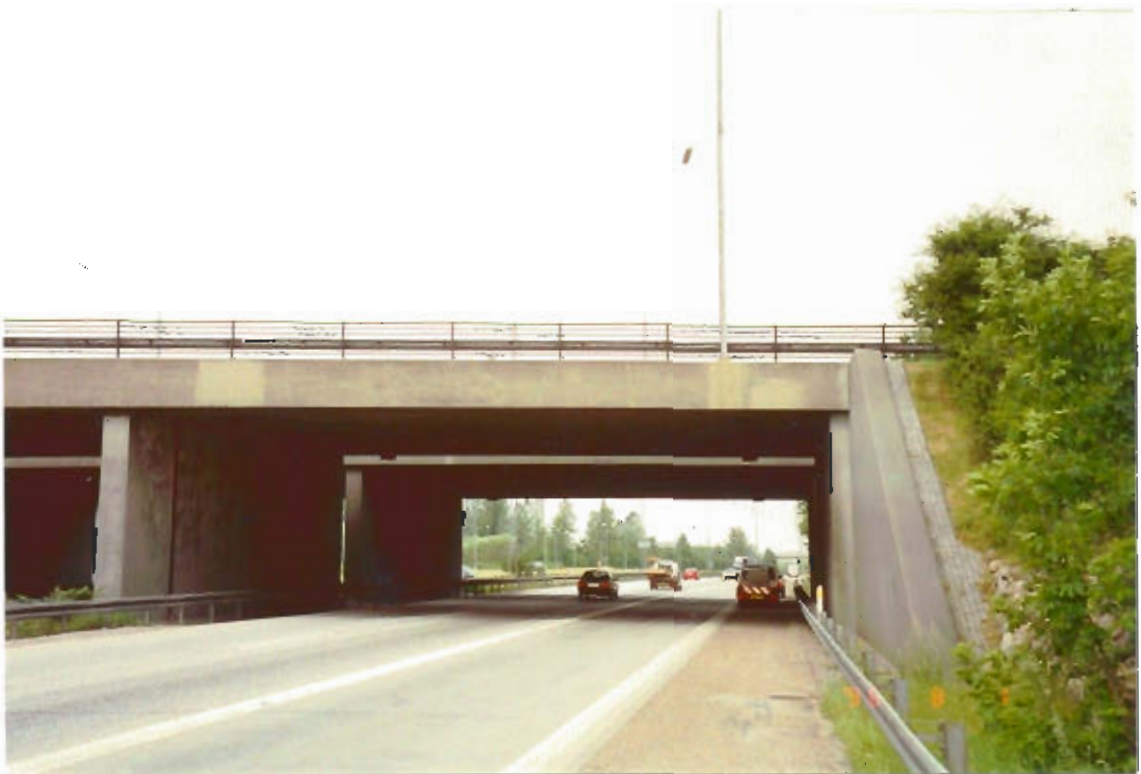
Figure 8: Bridge 4 was built in 1978. The two repairs which were inspected were holes from bad compaction on the outside of the edgebeam. The defects were repaired with shotcrete.

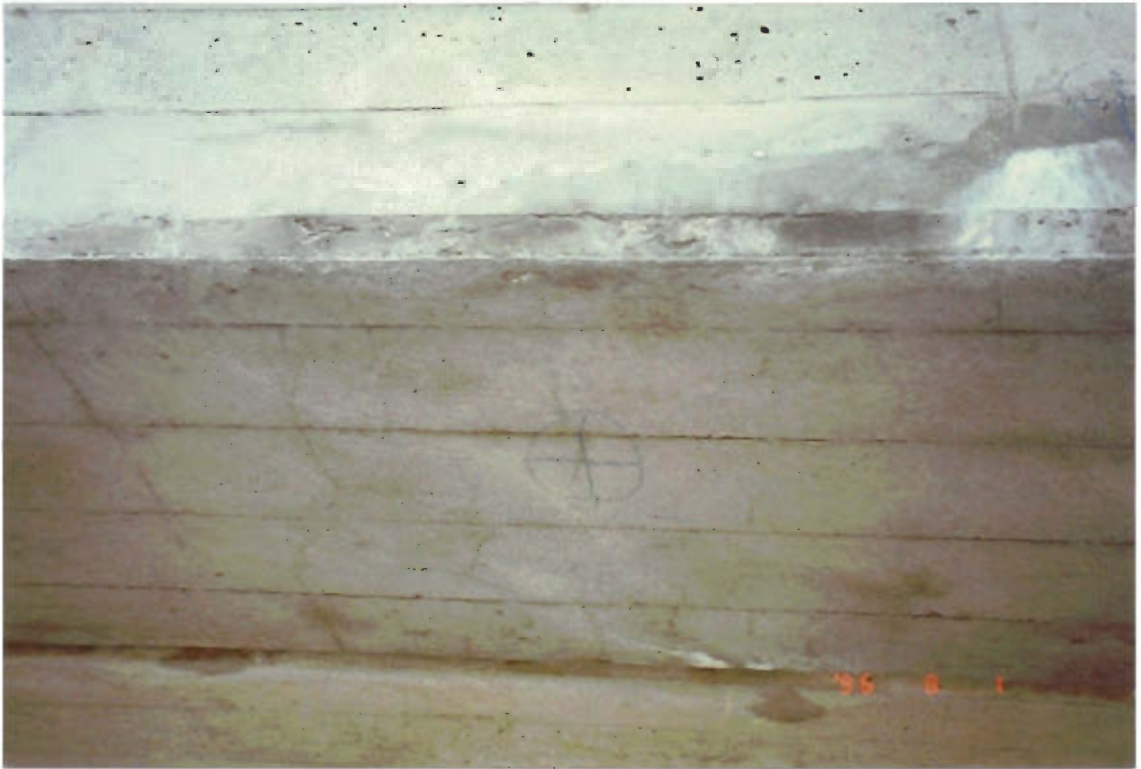
Figure 9: Repair under the edge of the bridge girder of bridge 3 - shotcrete repairs from 1978. Visual observations of the repairs are single cracks and white extrusions on the surfaces.

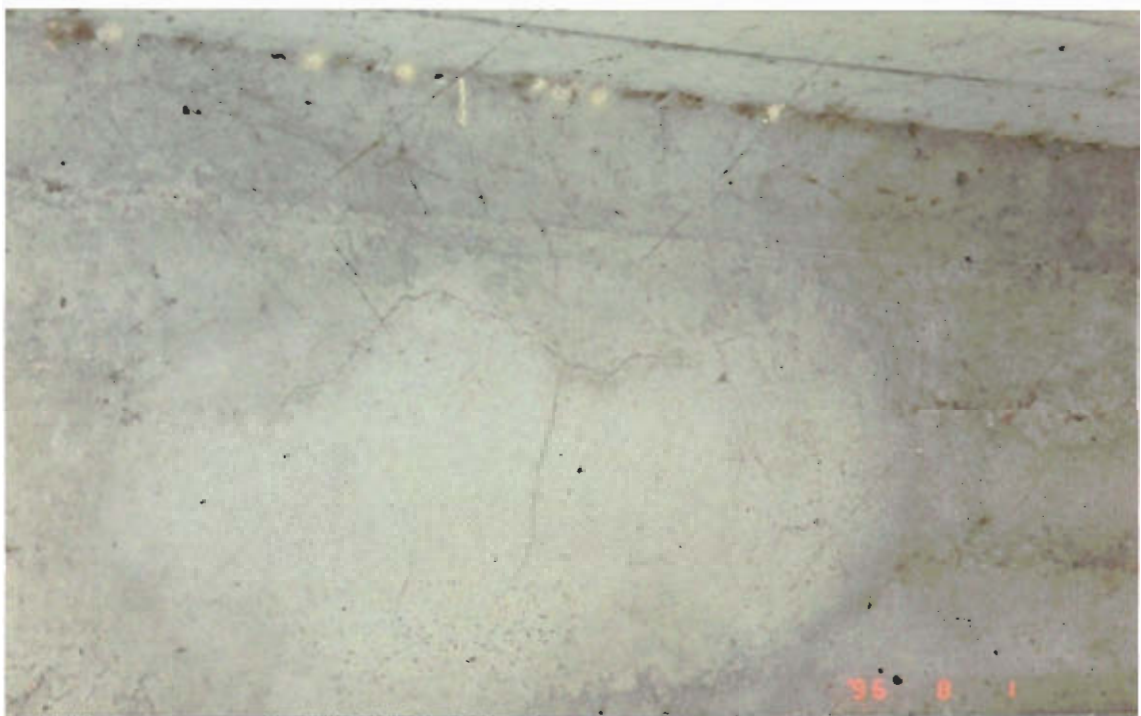
Figure 10: Repair under the middle of the bridge girder of bridge 3 - shotcrete repairs from 1978. Visual observations on the repairs are single cracks.

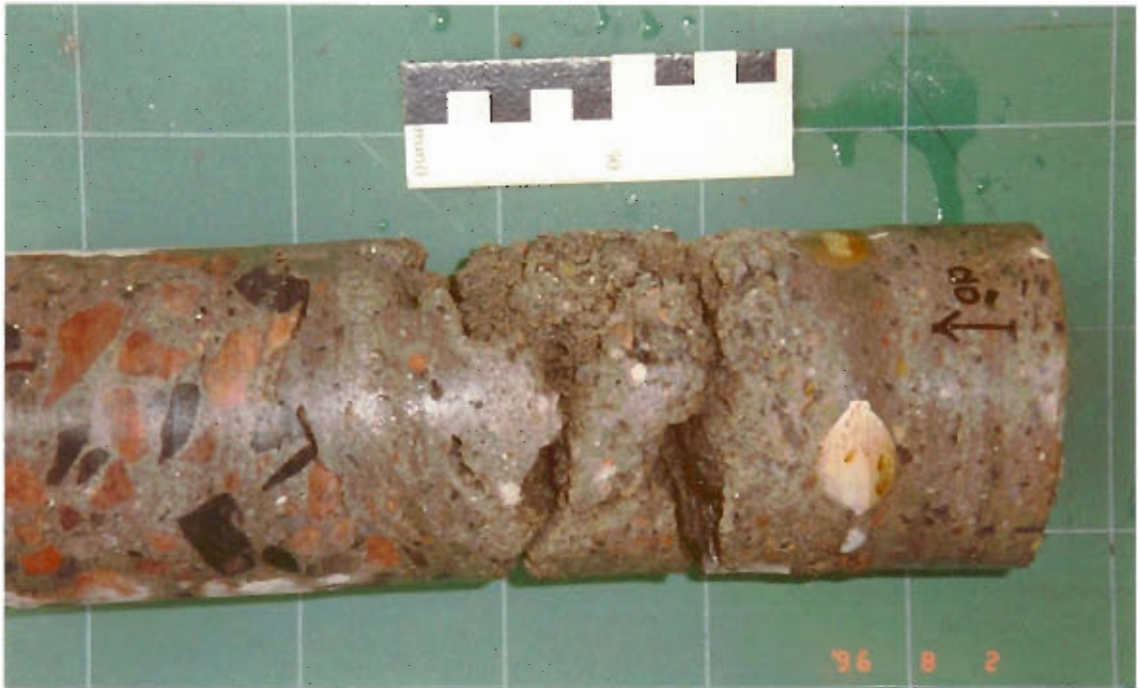
Figure 11: Bottom of the shotcrete repair of a bridge from 1987 (Bridge 3). The repair is very porous and the middle section has not been filled at all. The craftman has not been able to fill the repair while spraying from below which is the worst angle to use the shotcrete technic.

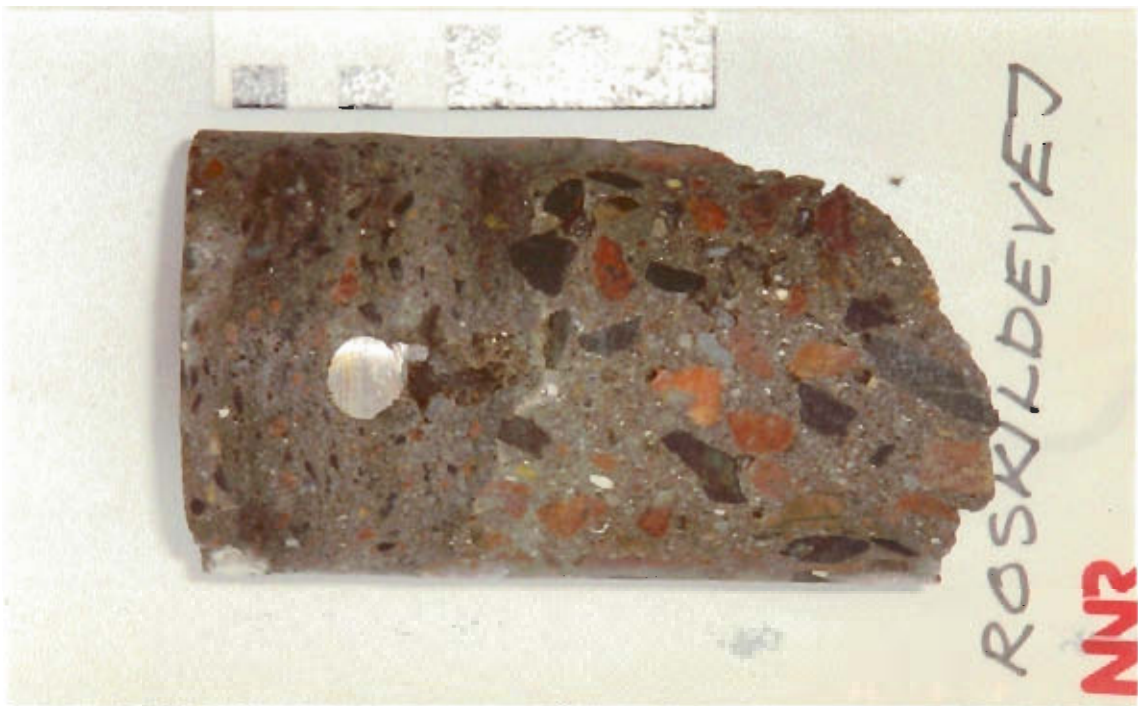
Figure 12: Shotcrete repair of the sidebeam of a bridge from 1978 (Bridge 4). There is a hole in the shotcrete behind the reinforcement. The craftman has not been able to fill the hole while spraying.

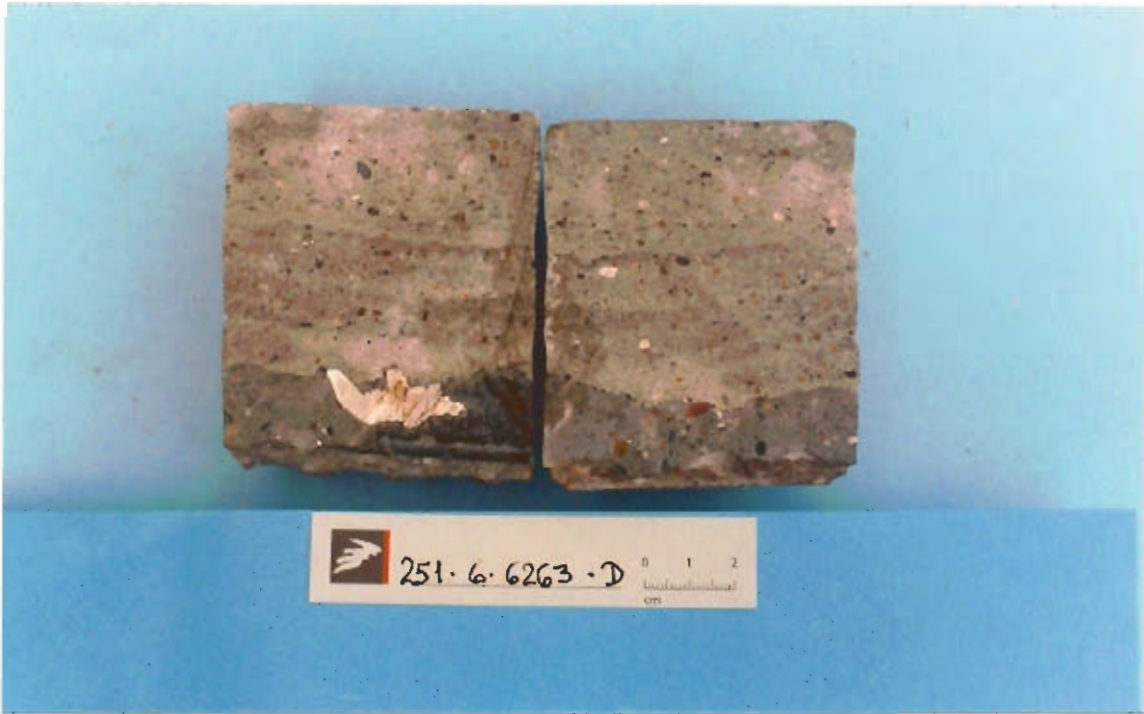
Figure 13: Shotcrete repair of a tunnel wall. The repair materials were well compacted with a homogeneous structure.

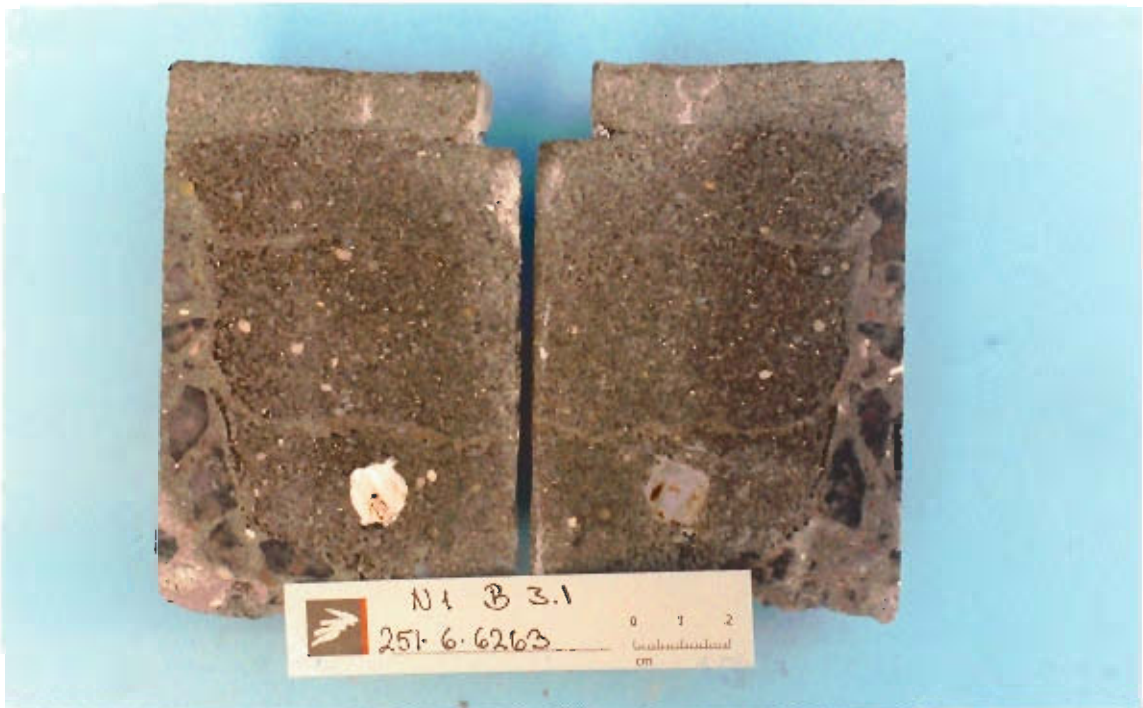
Figure 14: Repair with mortar on the inner side of the edge beam of bridge from 1996 (Bridge 2). The mortar is porous due to bad compaction and mixing and there is a weak section near the bottom part of the repair.

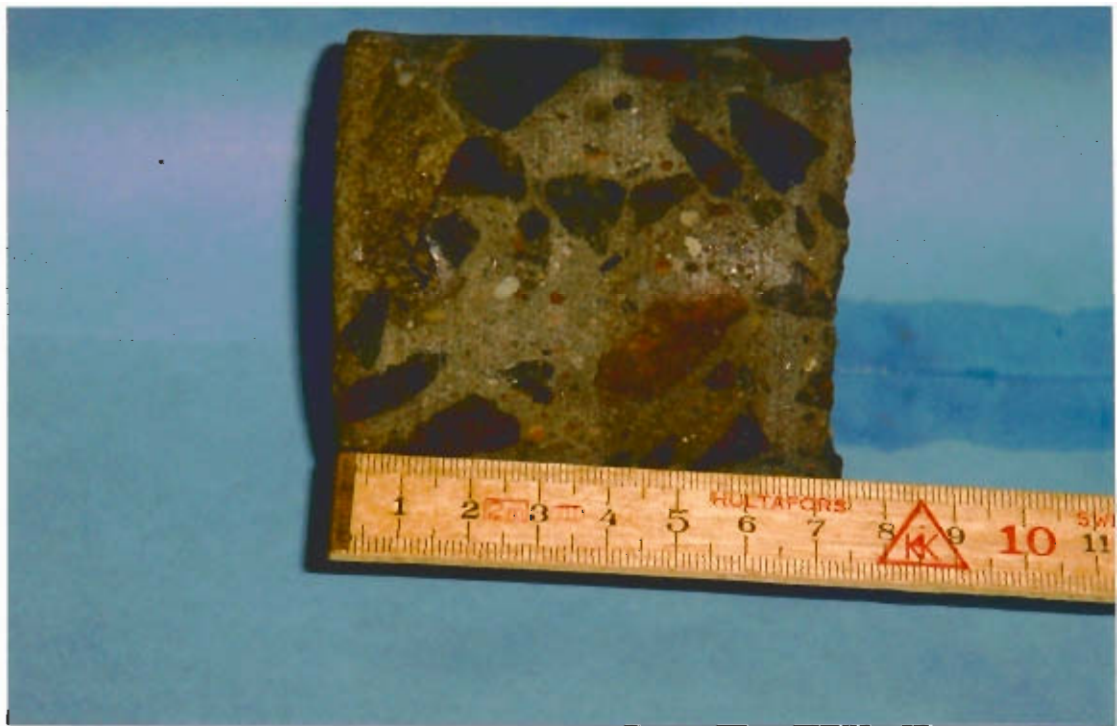
Figure 15: Repair with mortar in a tunnel wall. There is a hole in the section near the edge of the repair due to bad compaction.

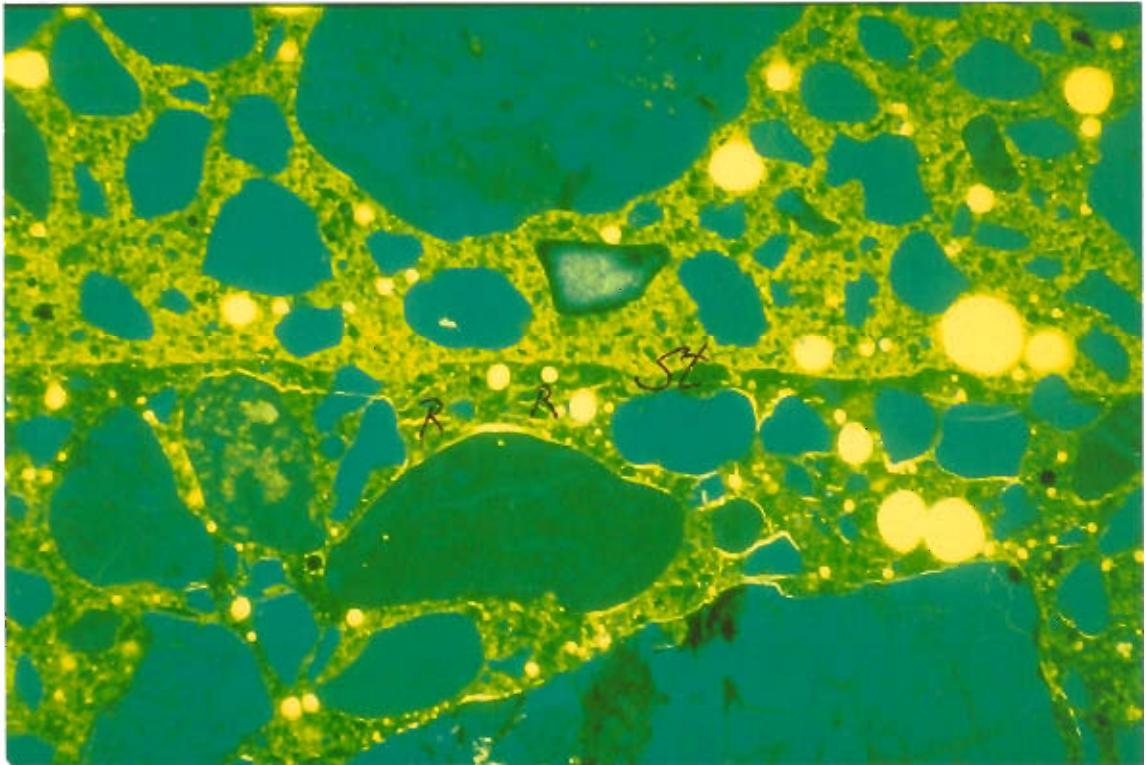
Figure 16: (Photo 5 from the enclosure 7) Illustration covers a section of app. 3 x 4 mm: Thin section prepared from the horizontal casting joint between repair concrete (made in the tunnel in 1996) and construction concrete. There was continuous adhesion and homogeneous structure of the repair concrete. There were parallel cracks (R) in the construction concrete indicating damages due to the demolition and removal of concrete before the repair. The cracks cause loss of adhesion strength and reduced durability of the repair.

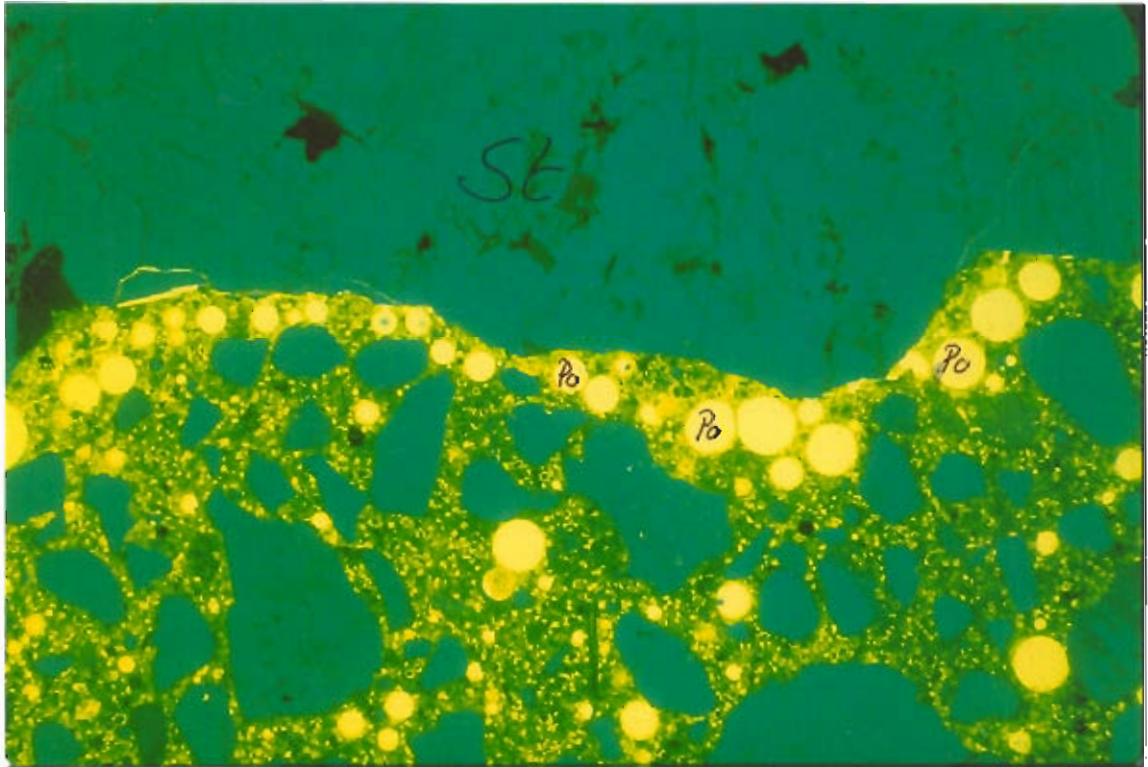
Figure 17: (Photo 6 from the enclosure 7) Illustration covers a section of app. 3 x 4 mm: Thin section prepared from the internal part of repair concrete made in the tunnel in 1996. Air bubbles were located along the stones, thus indicating insufficient compaction of the repair concrete.

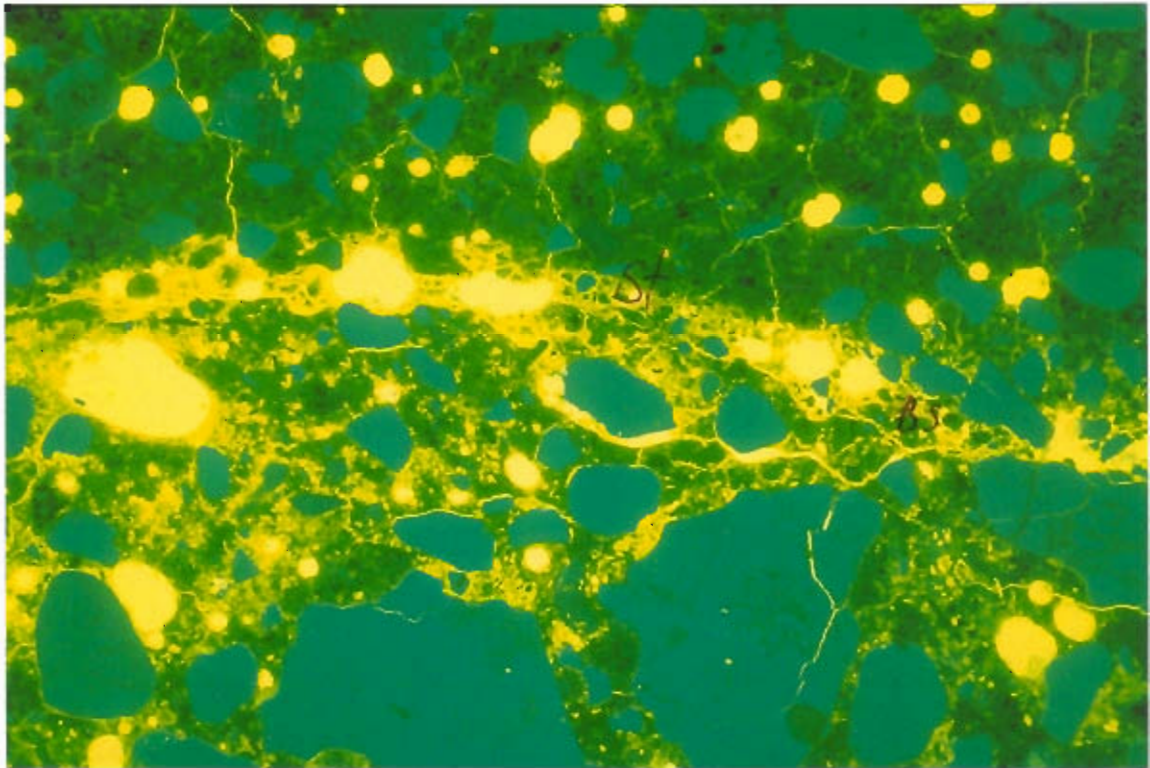
Figure 18: (Photo 17 from the enclosure 7) Illustration covers a section of app. 3 x 4 mm: Thin section prepared from the internal casting joint between shotcrete at the top part and construction concrete. The repair were made on the side beam of a bridge in approximately 1978. There is dust and dirt on the surface of the casting joint which cause lack of adhesion.

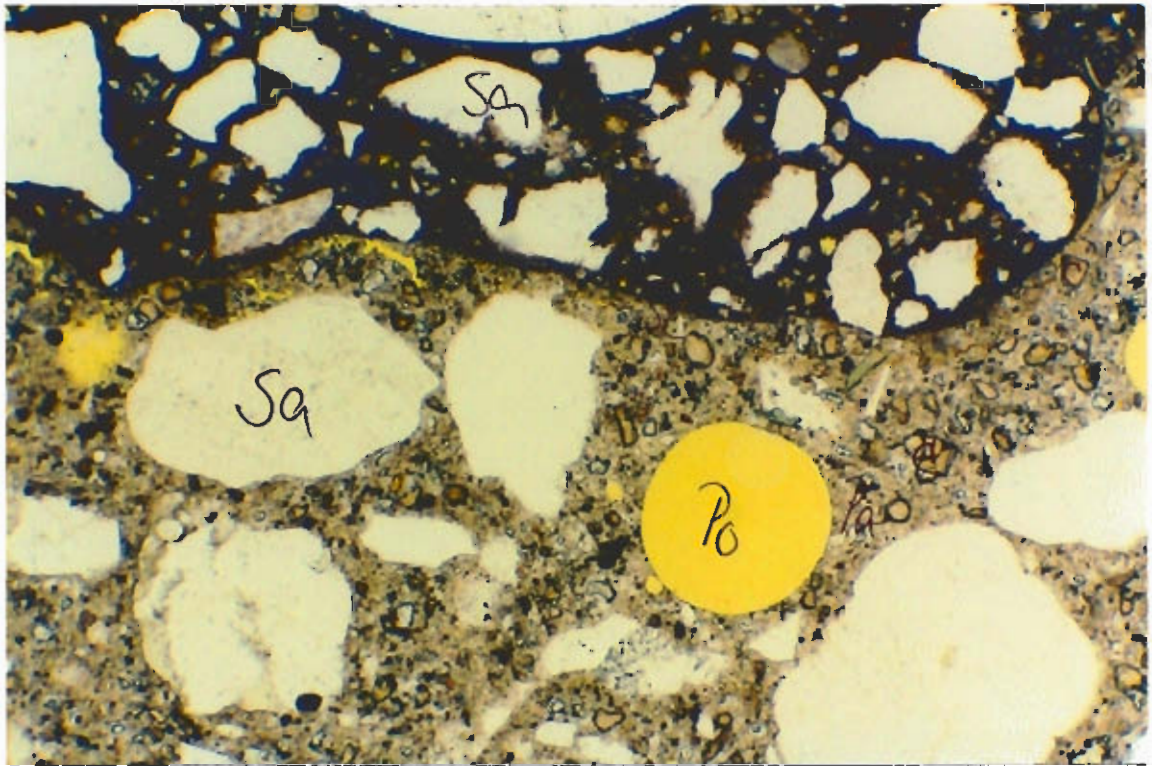
Figure 19: (Photo 19 from the enclosure 7) Illustration covers a section of app. 3 x 4 mm: Thin section prepared from the internal casting joint between mortar at the top part and construction concrete. The mortar is of good quality without inhomogenities.

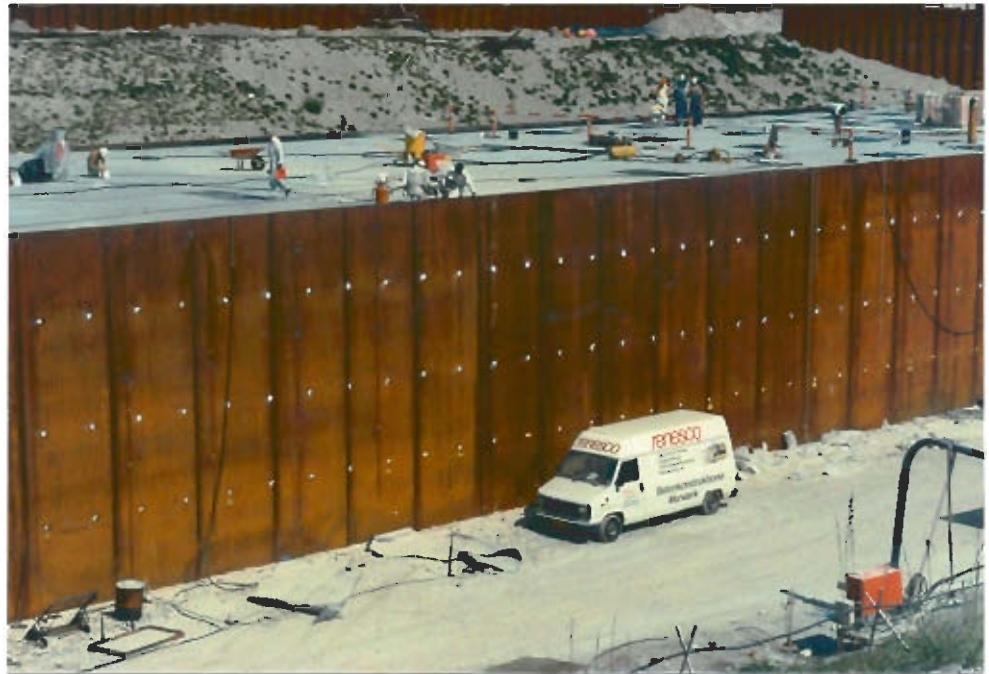
Figure 20: (Photo: RENESCO) Injection of cracks on the top deck of a tunnel. The injection included more than 900 injection valves in drilled holes and more than 900 litres of acrylic injections materials were used.

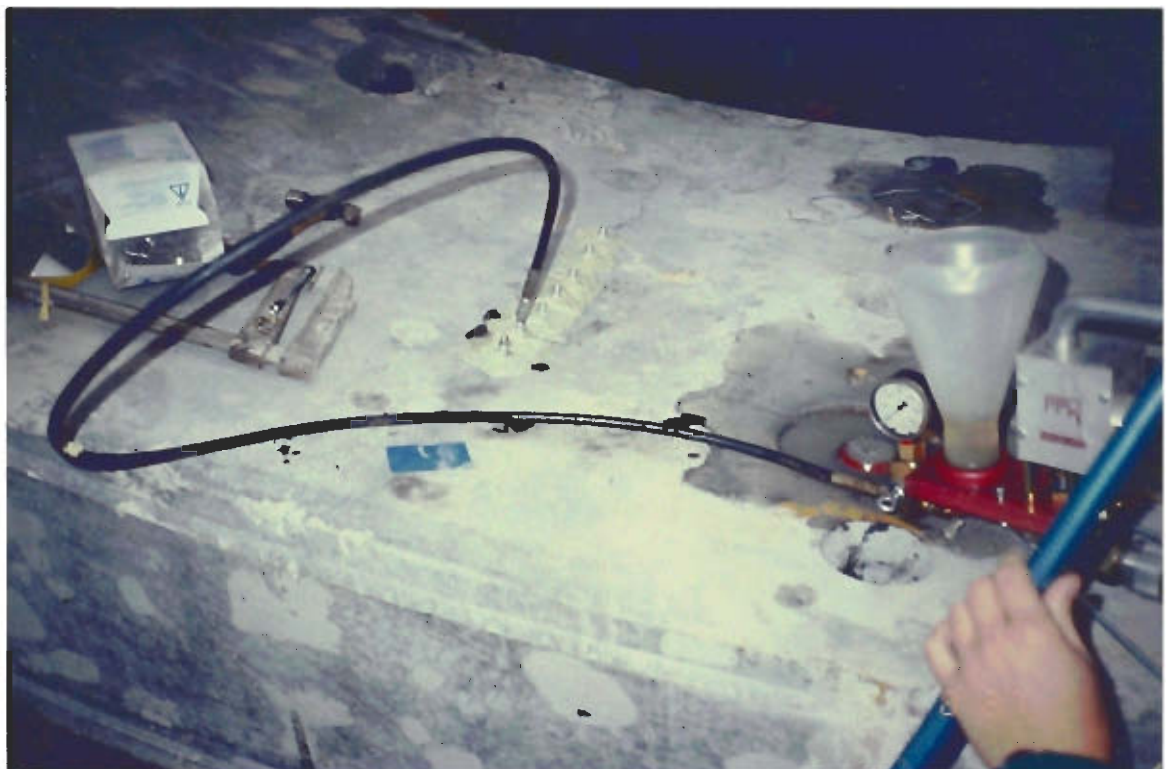
Figure 21: (Photo: E. Kluge) Injection of cracks with epoxy resin. Nipples are glued to the concrete surface on the top of the crack.
