# Big Data, Internet of Things, digitalisering.

Niels Boel & Peter Fritzøger  
Schneider Electric

# Building Advisor

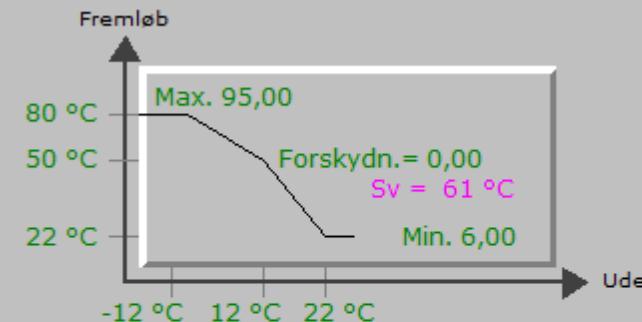
ENERGI-STOP  
Ved ønsket fremløb under 25 °C

M100 til OPC demo  
BLANDEANLÆG SYD

Udetemp. 3 °C  
28-02-2017 14:13:30

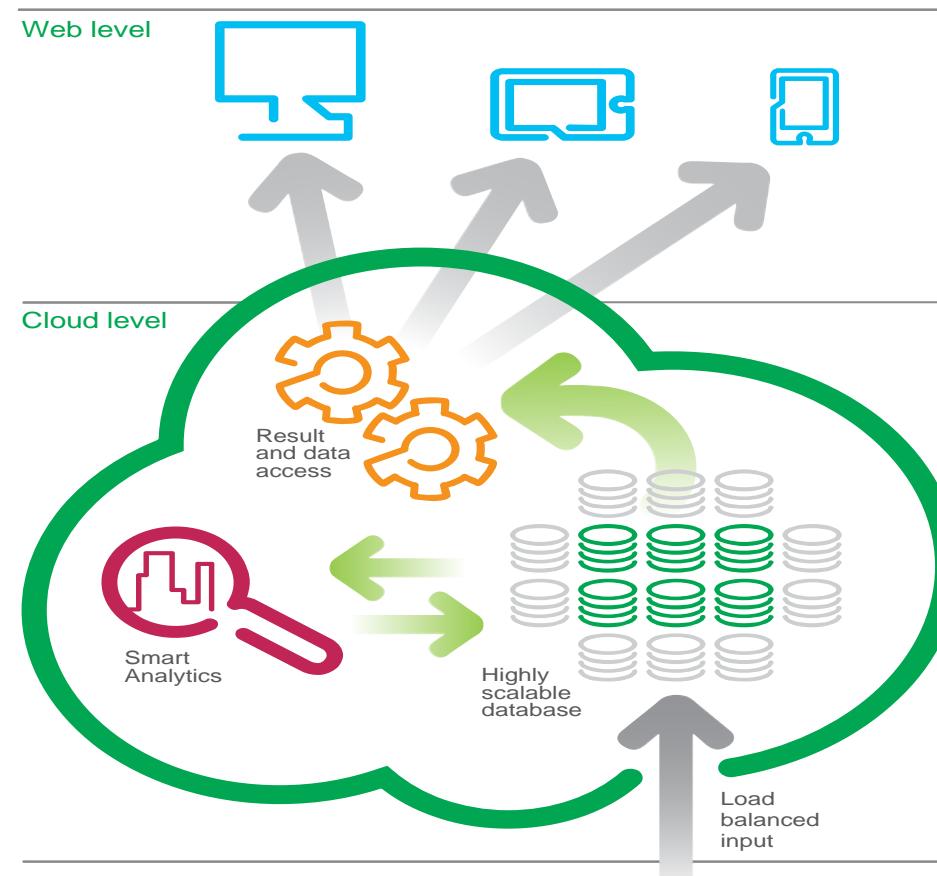
# Systemarkitektur

Data fra bygningsautomatiksystemer  
Schneider Electric og andre BMS/CTS leverandører
