# Report

## Cleaning with less water

### Ultraviolet light inspection with Bactiscan

P2008770

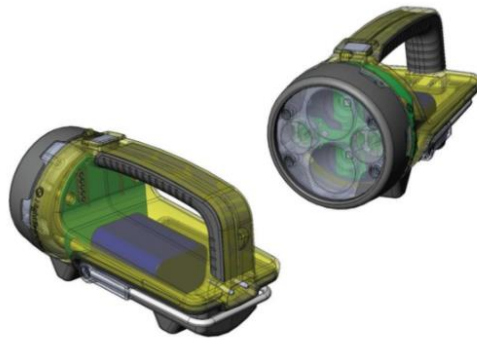
**Figure 1.** Bactiscan UV lamp. Figures from food-supply.dk

Bactiscan is a handheld ultraviolet (UV) lamp. UV-light causes some types of organic material to fluoresce, making these types of contaminations easier to detect during visual inspection.

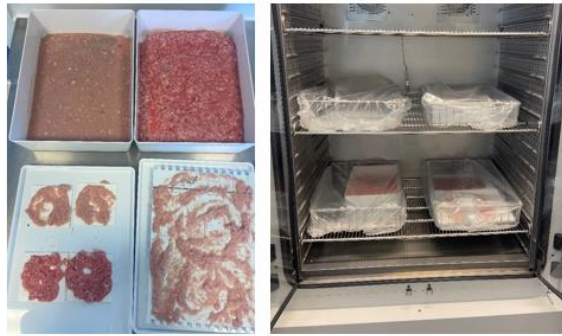
Various surfaces were soiled with a suspension of either minced pork or canned cooked meat (Jaka bov) inoculated with known meat spoilers: *Pseudomonas* (DMRICC 4760) and *Brochotrix* (DMRICC 4613). These bacteria were selected as a previous study showed that strong to medium light fluorescence was observed for these species (Campden BRI, 2020). The soiled surfaces were incubated at 12°C and at 98% RH for 11 days (Figure 2).

**Figure 2.** Soiled surfaces with meat suspensions inoculated with bacterial spoilers. All surfaces were incubated for 11 days for biofilm formation.

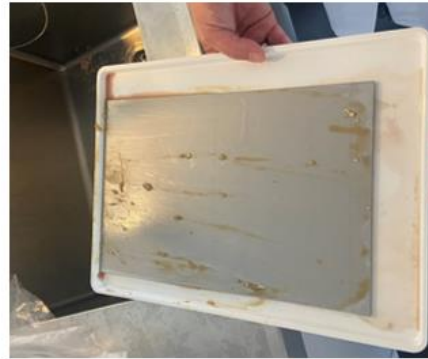
C) After scrubbing

D) After scrubbing, with UV light

Steel surfaces with spoiled meat	Fluorescence	Log cfu/sample
After scrubbing	Green spot (Fig. 3C and 3D)	6.9
After rinsing with water	No fluorescence (Fig. 3E)	5.5
Modular belt with spoiled meat		Log cfu/sample
After rinsing with water	Blue spot (Fig. 3H)	3.4
Flat belt with spoiled meat (Fig. 3F)		Log cfu/sample
After rinsing with water	Green spot/lines in crevice (no picture)	6.9
After rinsing with water	No fluorescence (Fig. 3F)	6.2
Others		Log cfu/sample
Surface with limescale	Green spot (no picture)	1.7
Surface with limescale	Blue spot (no picture)	2.0

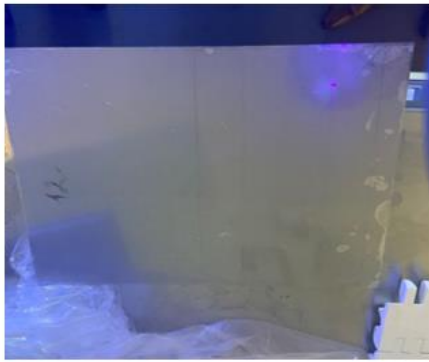
E) After rinsing, with UV light (visual clean)

*Result of laboratory test* The laboratory test shows that the Bactiscan makes dirty surfaces easily detectable. However, it does not create fluorescence on surfaces that are visibly clean even though they have a large bacterial load (Fig. 3E, Fig. 3F and Table 1). No clear correlation appears between fluorescence and the bacterial plate count (Table 1).

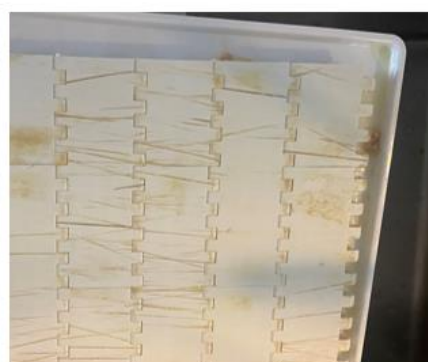
G) Modular belt after rinsing

H) Modular belt after rinsing, with UV light

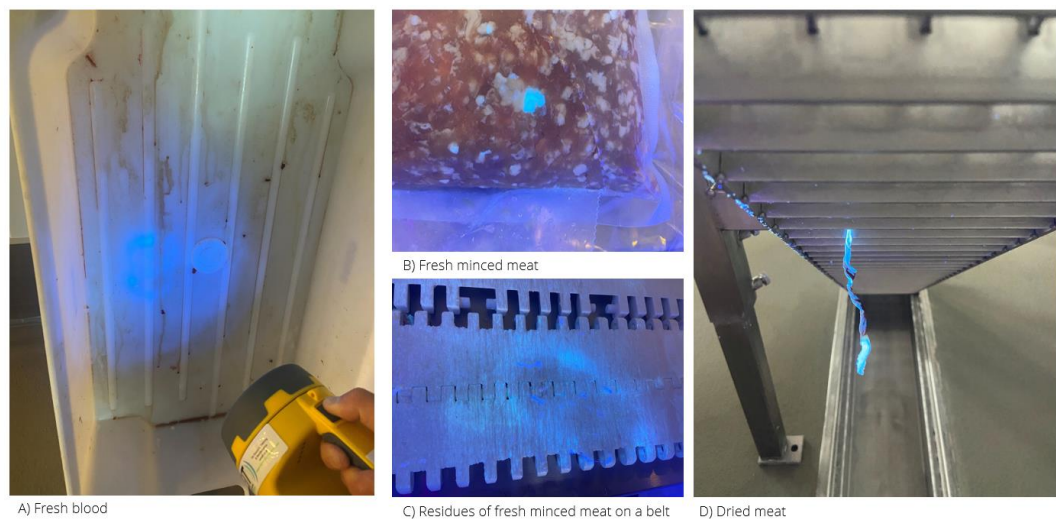
The Bactiscan was also tested on meat and blood. Fresh blood and minced meat did not fluoresce, only small bits of cartilage in the minced meat lid up (Fig. 4A and B). In contrast, residues from the minced meat and dried meat did fluoresce in the UV light from the Bactiscan (Fig. 4C and D). It is possible that the high water content of fresh meat and blood prevents reflection of the UV light.

**Figure 4.** UV- inspection of fresh meat and blood (a,b,c) and dries meat (d).

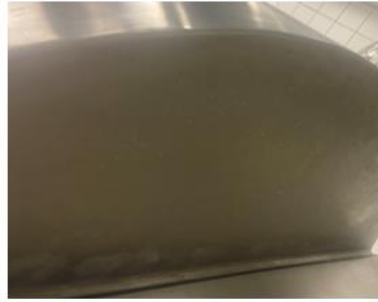
The Bactiscan helped discover several areas with insufficient cleaning that had been overlooked in the usual visual inspection without aids (Fig. 5). It was especially the underside/backside of the equipment (Fig. 5A, B, E, F, K and L) and on the floor below the equipment (Fig. 5C and D) that insufficient cleaning was discovered during the extra inspection with the Bactiscan. In all these instances, the contaminants were also visible without the UV light, but it had none the less been overlooked in the usual visible inspection. In contrast, the vacuum packer was visibly clean, but showed a strong fluorescence (Fig. 5I and J), and a swap revealed a high plate count (Table 2).

A) Underside of equipment - UV

B) Underside of equipment

Area	Log cfu/sample
The underside of an equipment (Fig. 5A)	2.7
Floor below equipment (Fig. 5C)	3.3
Blade (Fig. 5E)	1
Tiles (Fig. 5G)	1.7
Vacuum packing machine (Fig. 5I)	4.1
Vacuum tap and pipe (Fig. 5K)	2.9
Sausage clipper/clipping machine	1
Door frame	4.3
Smoke oven	1.7

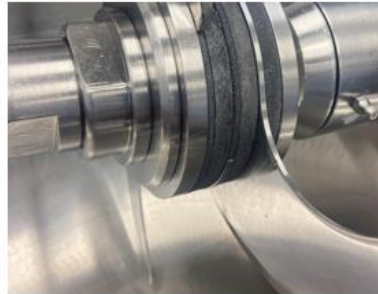
E) Blade - UV

F) Blade

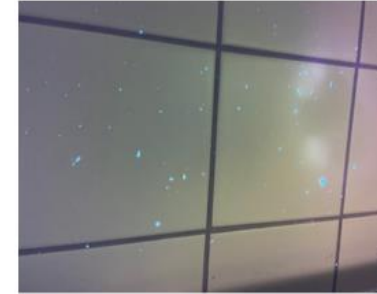
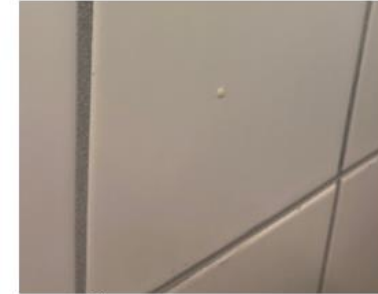
G) Wall - UV

H) Wall

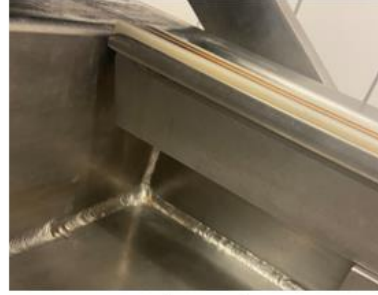
I) Vacuum packer machine - UV

J) Vacuum packer machine

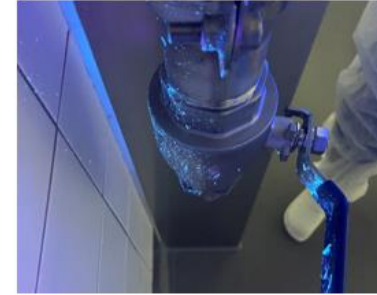
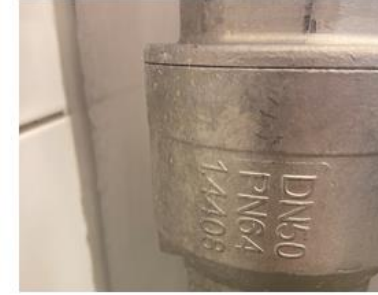
K) Vacuum valve - UV

L) Vacuum valve
