# PV-ROCK-ROOF

Mock-up test report

EUDP, project no. 64019-0029

May 2022

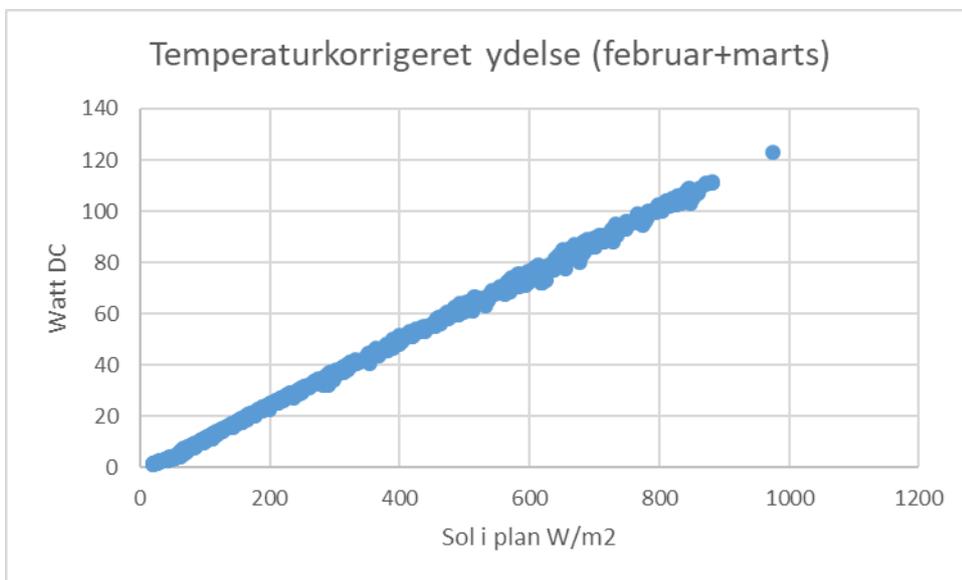
Figure 1 Long term measurements from a former test of the old generation of red modules show a total STC power of 125 Wp.

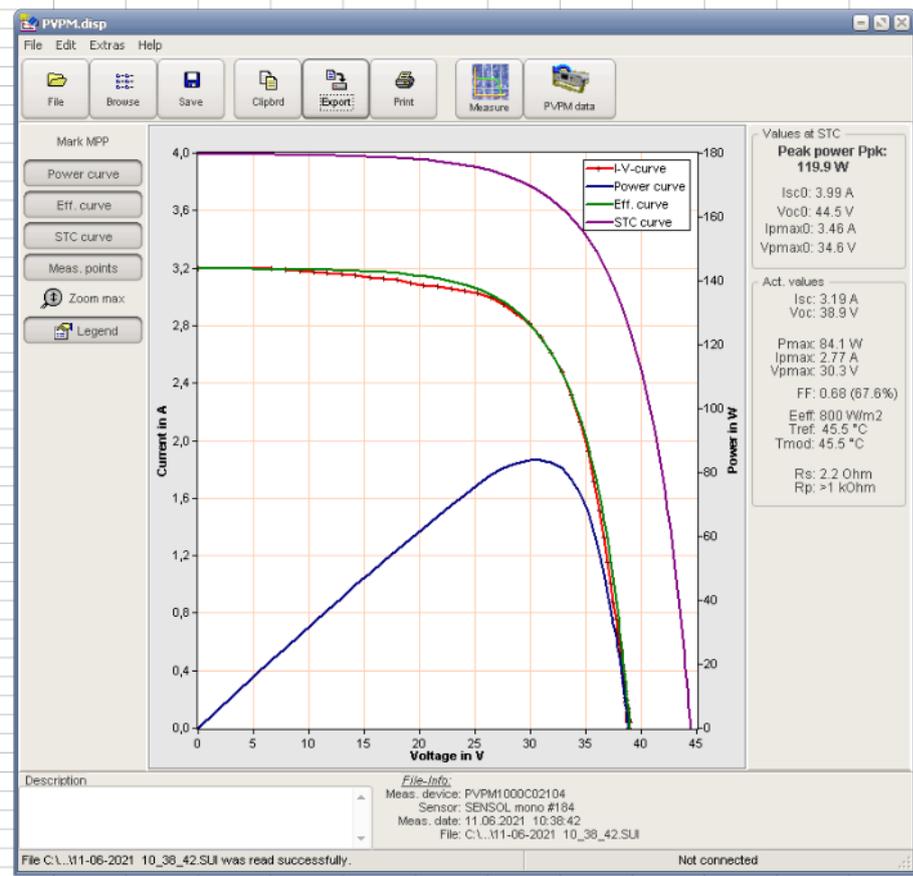
Figure 2 Readout from PVP620 IV curve analyzer.

The initial measurement of the IV-curve shows a total STC power of 120 Wp for the three old modules. However, the IV cure analyzer does not measure the cell temperature directly but use the irradiance sensor temperature as proxy. Because the PV modules are approximately 10K warmer (manual reading) than the sensor, a correction factor of  $10K * 0,4\%/K = 4\%$  is applied:

$$P = 1,04 * 119,9 = 124,7\text{Wp} \text{ (41,6 Wp per module)}$$

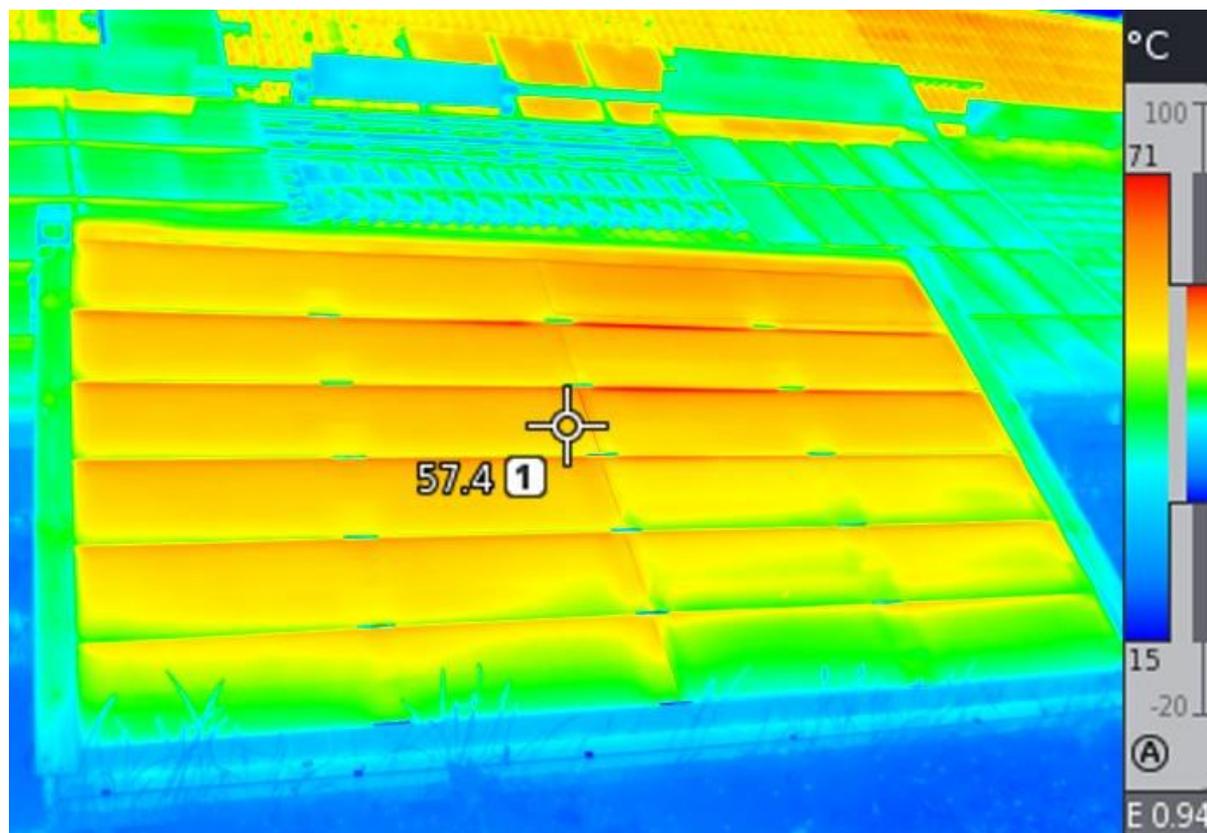
Figure 3 IR photo with idle PV modules.

Thermal imaging was conducted on a sunny day to get an overview of the temperature distribution of the roof surface. At first, the modules were not producing power, and thus the solar energy is either reflected or absorbed and converted to heat. The temperature is relatively uniform.

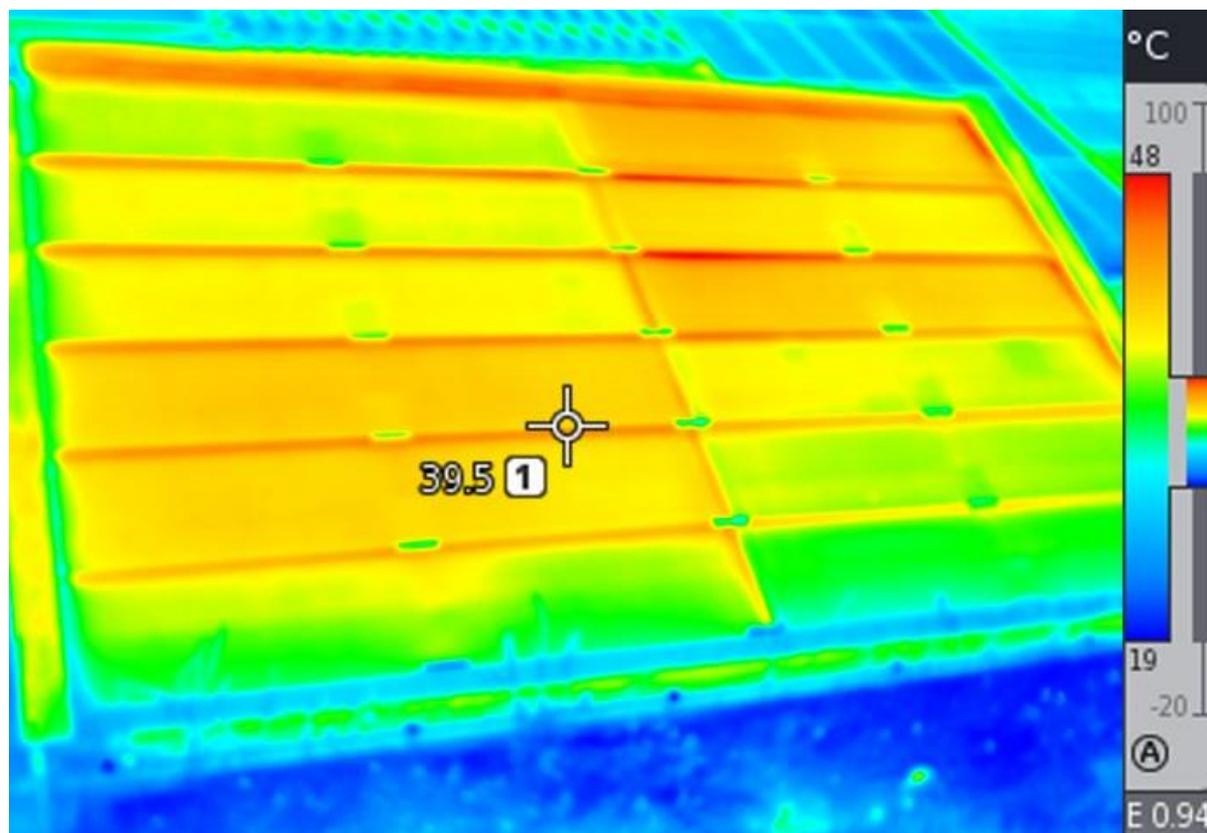
Figure 4 IR photo with active PV modules.

When the modules are producing power, some of the energy is extracted as electricity, and the modules get colder. There is also some difference between the modules due to different colour and position in the array.

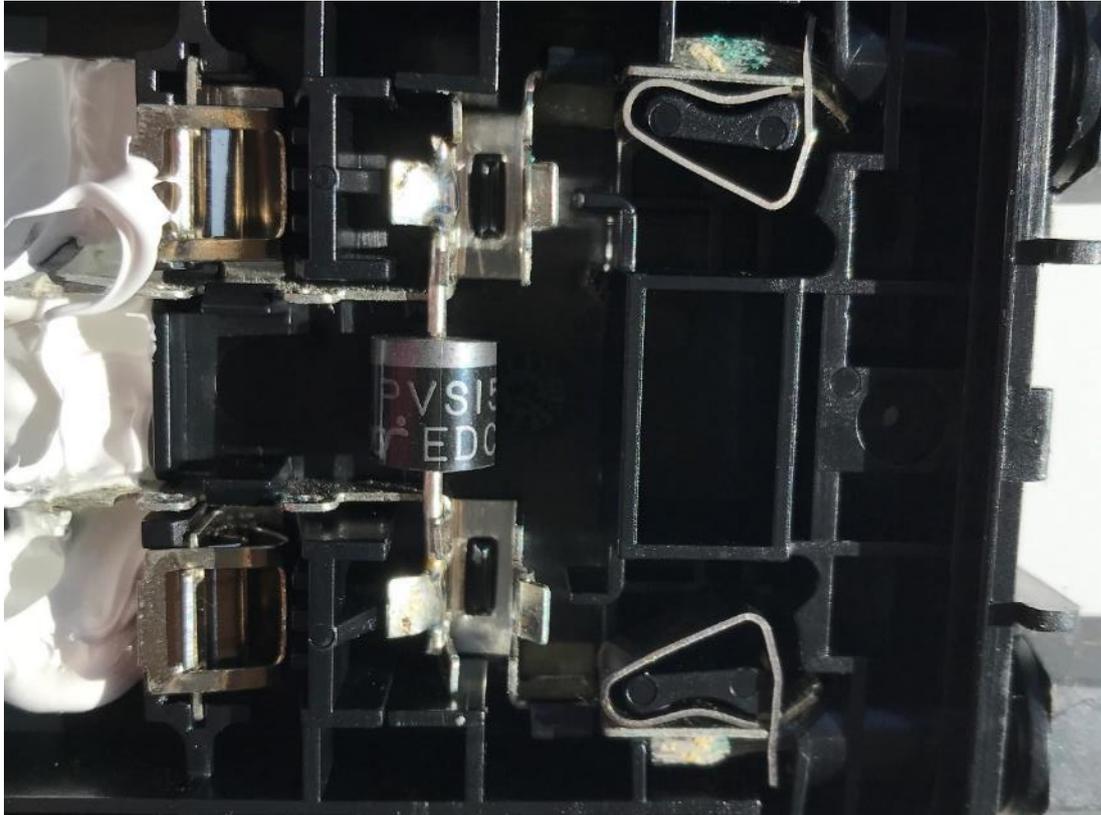
Figure 5 Diode box with visible corrosion products on cable ends.

- No signs of water intrusion or excess humidity
- No signs of temperature damage or deformation of plastic parts
- Sign of corrosion on cable ends in junction boxes. DSE explains it could be because they used a silicone that gasses acetic fumes in the hardening process. Normally they use a neutral silicone.

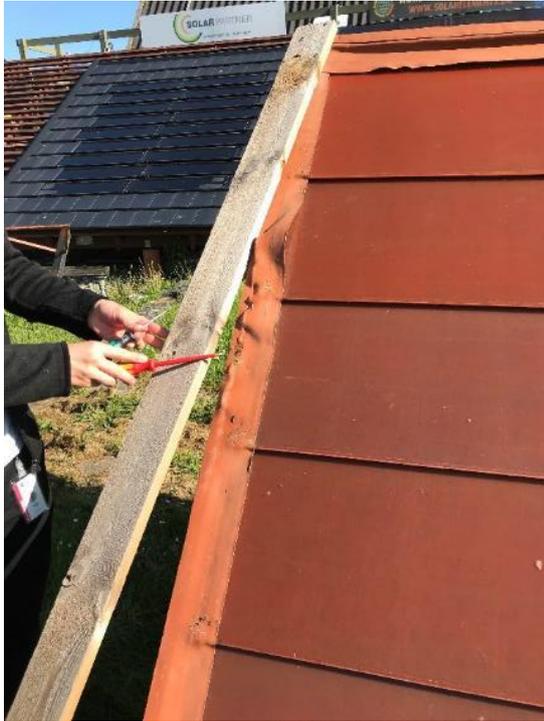
Figure 6 Disassembly of edge profile and bitumen tape.

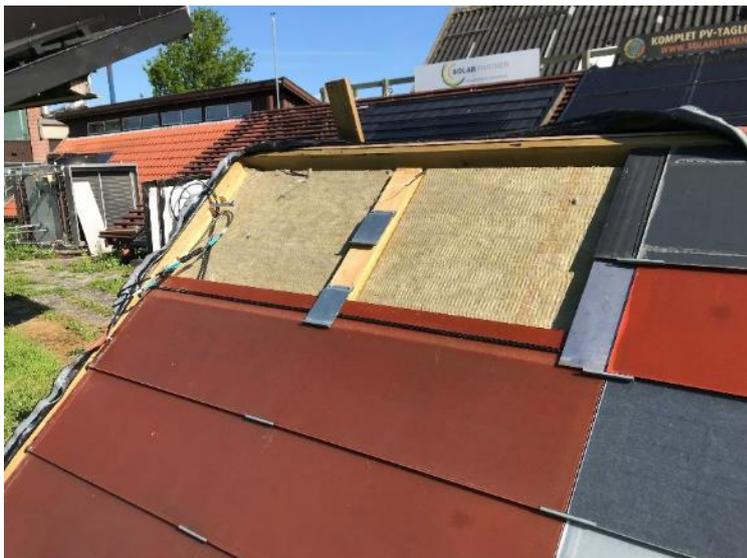
Figure 7 Removal of old modules from top and down. A rubber strip can be seen on the old module.

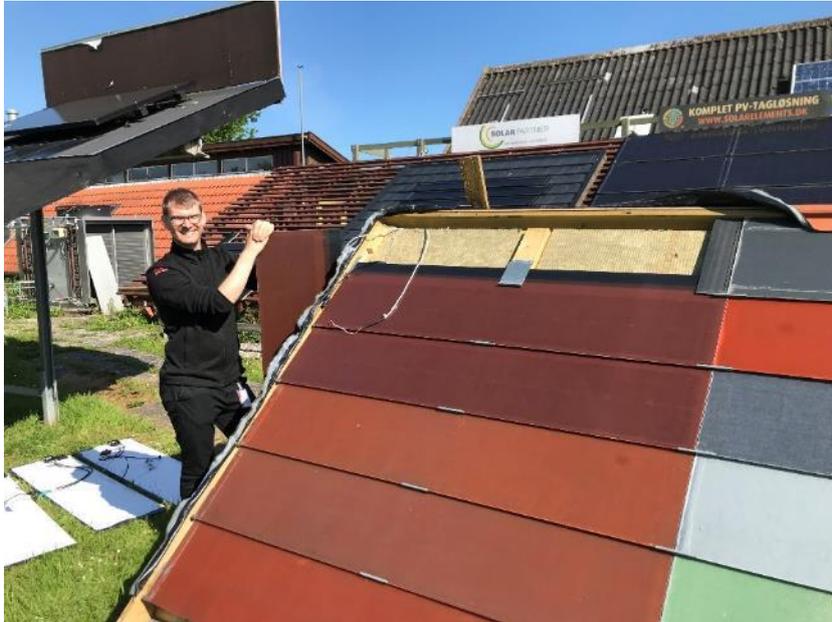
Figure 8 Two new modules mounted. There is no rubber strip on these.

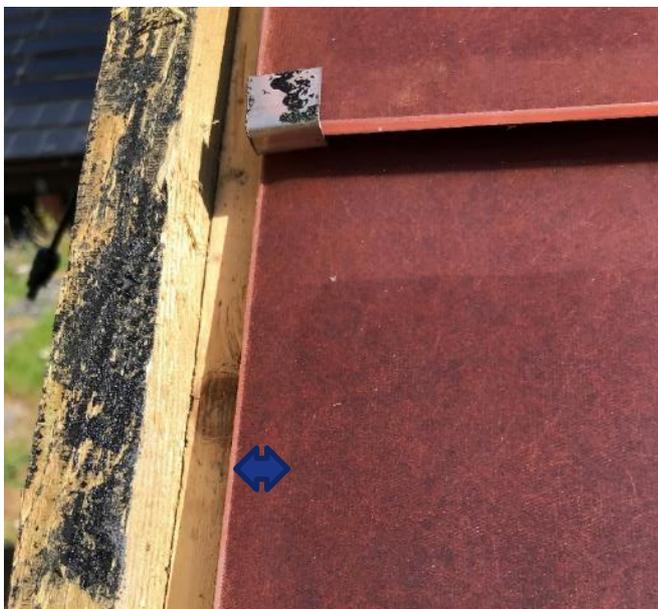
Figure 9 Due to narrow clearance from the PV cells to the edge of the glass, it was necessary to move the outer profile to avoid shadow of the cells.

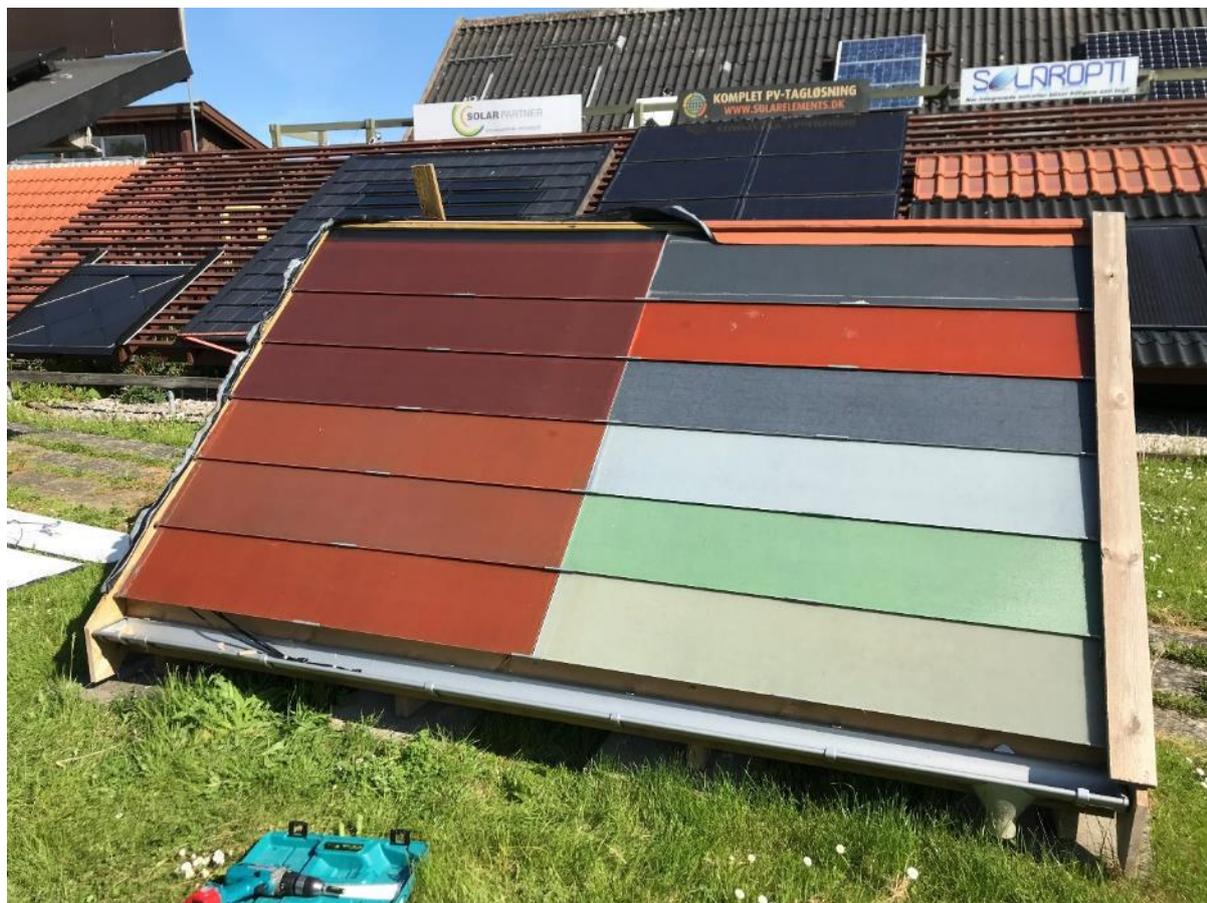
Figure 10 Final result, though the edges not repaired.

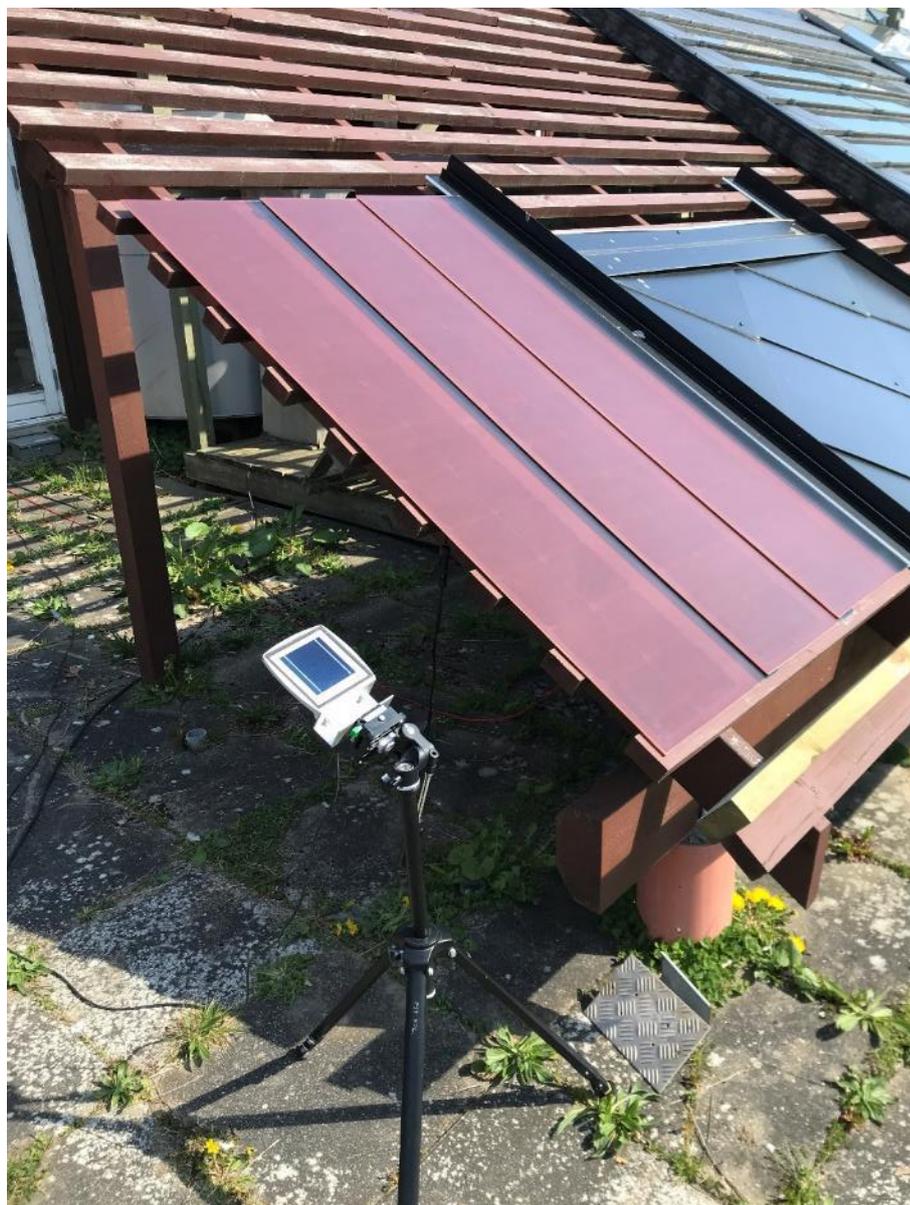
Figure 11 Set up for IV curve measurements with PVPM 6020 analyzer.

Before placing the new modules in the mock-up, a measurement was made on each module individually and on all three in series. The measurements show a somewhat irregular curve; however, the power is much higher than for the old modules.

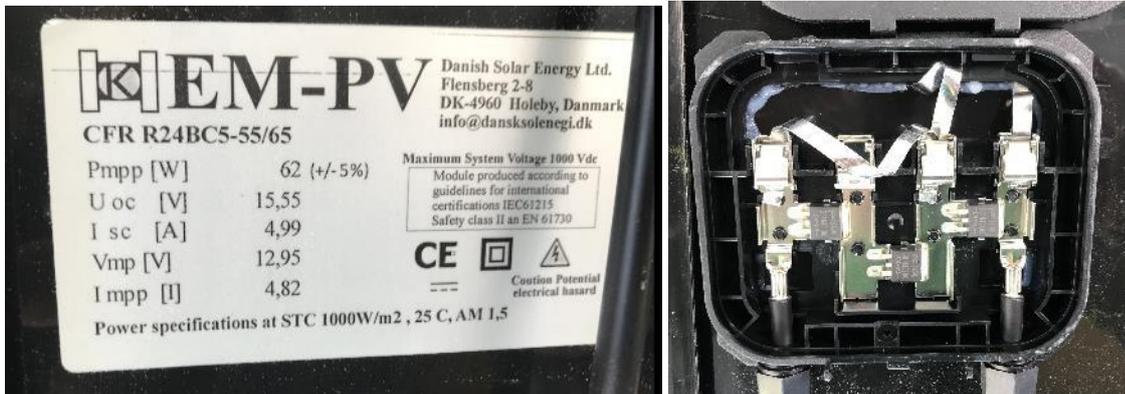
Figure 12 Name plate and junction box of the new modules.

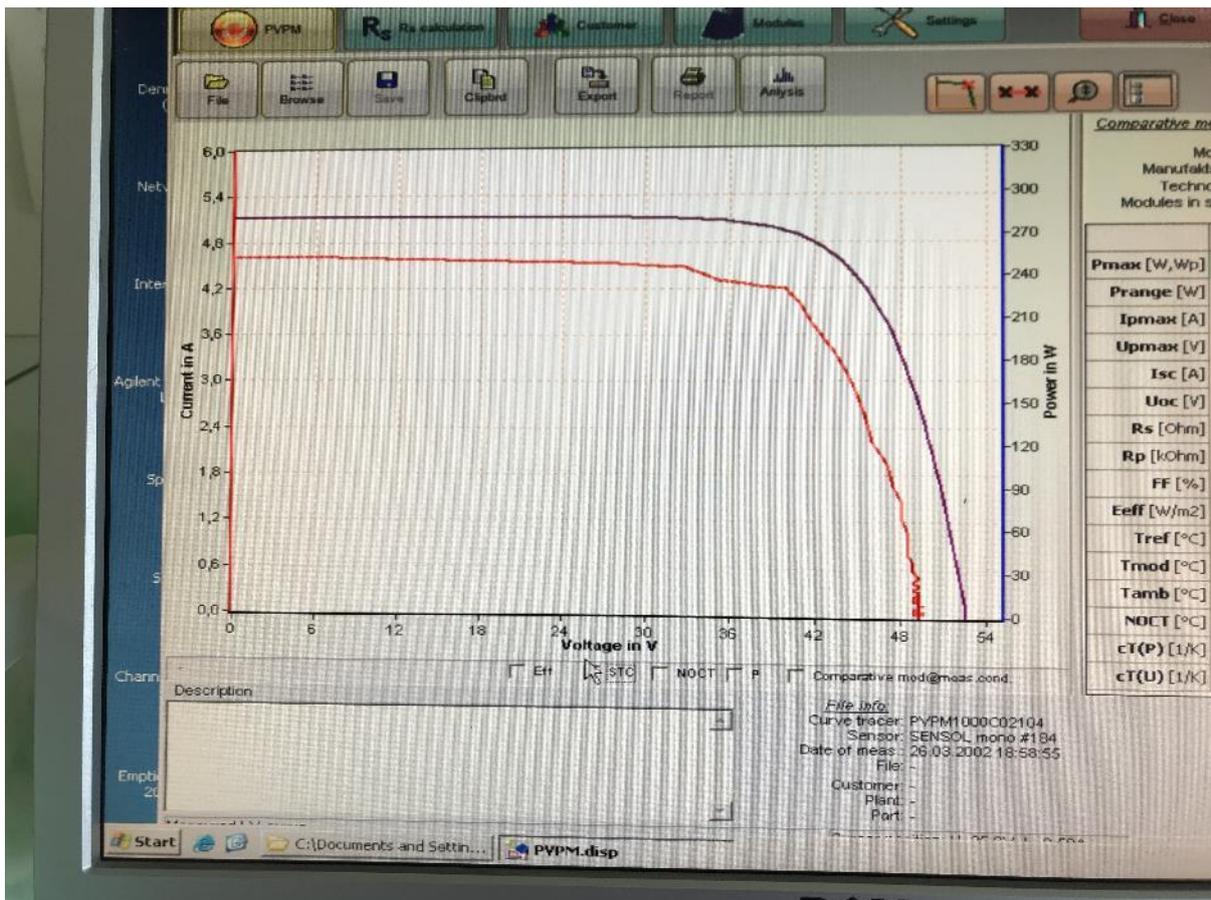
Figure 13 Photo of the measured IV curve for the modules in series connection. The red curve indicates some degree of mismatch, maybe due to variation of light absorption in the coloured interlayer.

The measured and STC corrected values for the new modules are: 198,9 Wp or 66Wp average per module.

The old modules are 124,7 Wp, so the new generation is performing 60 % higher for the same area.

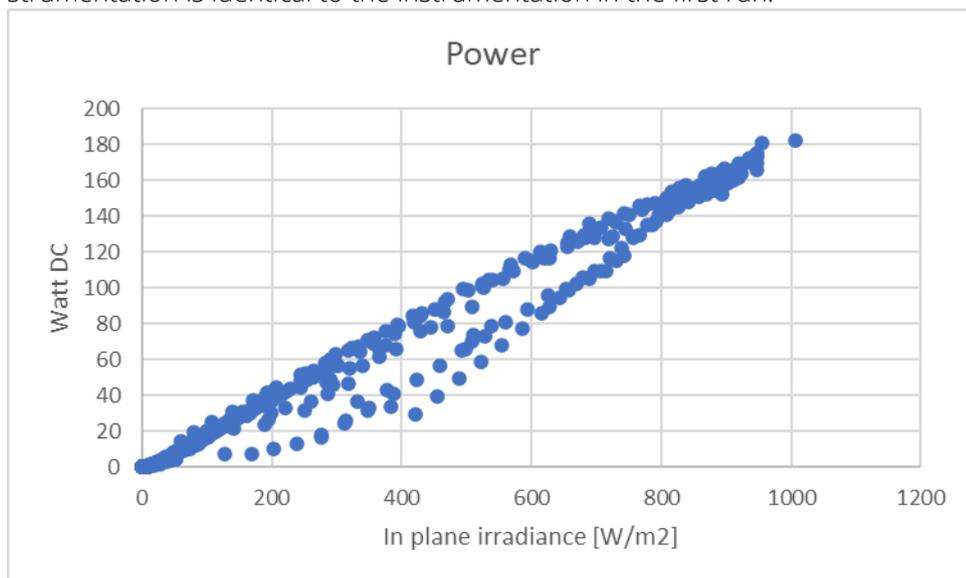
Figure 14 Power as a function of irradiance shows a band where the upper limit is close to the measured STC value. The lower band shows the power limitation due to shading effects in the afternoon.

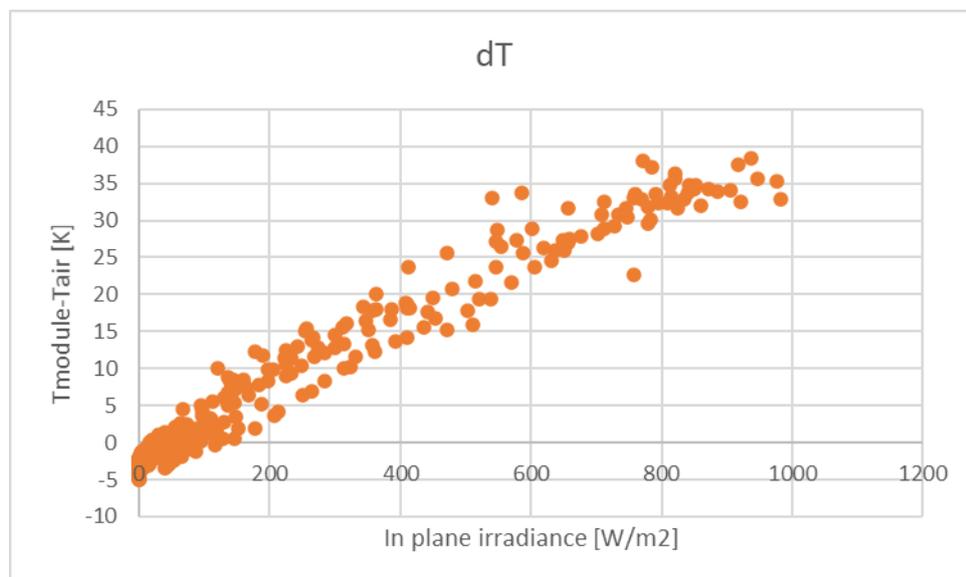
Figure 15 Module overtemperature as a function of irradiance.

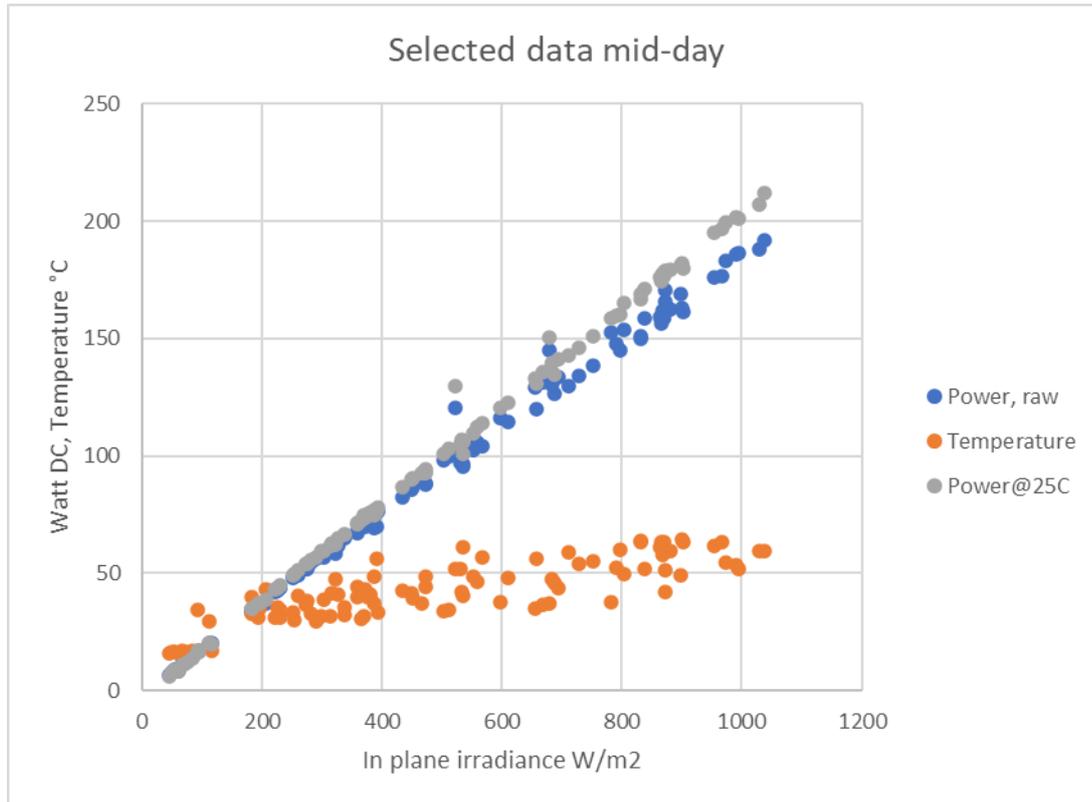
Figure 16 Power as a function of in plane irradiance confirm the nominal power of approximately 200 Wp for all three modules together.

As a check of the power level at standard testing conditions, data was selected for times with near perpendicular insolation and power corrected to a module temperature of 25 °C. The result at 1000 W/m<sup>2</sup> is very close to the power measured with the IV curve analyzer.
